Upper Makefield Township - Watershed Restoration Plan  
Community Workshop

09.11.2018

# Upper Makefield Township Watershed Action Plan

Community Workshop

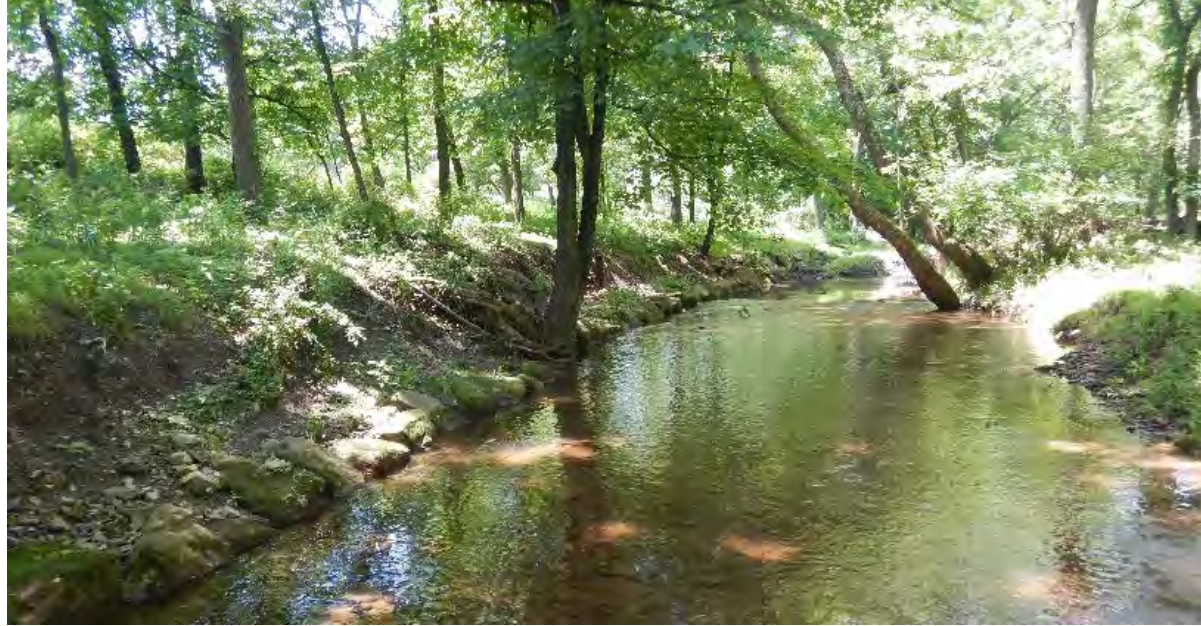
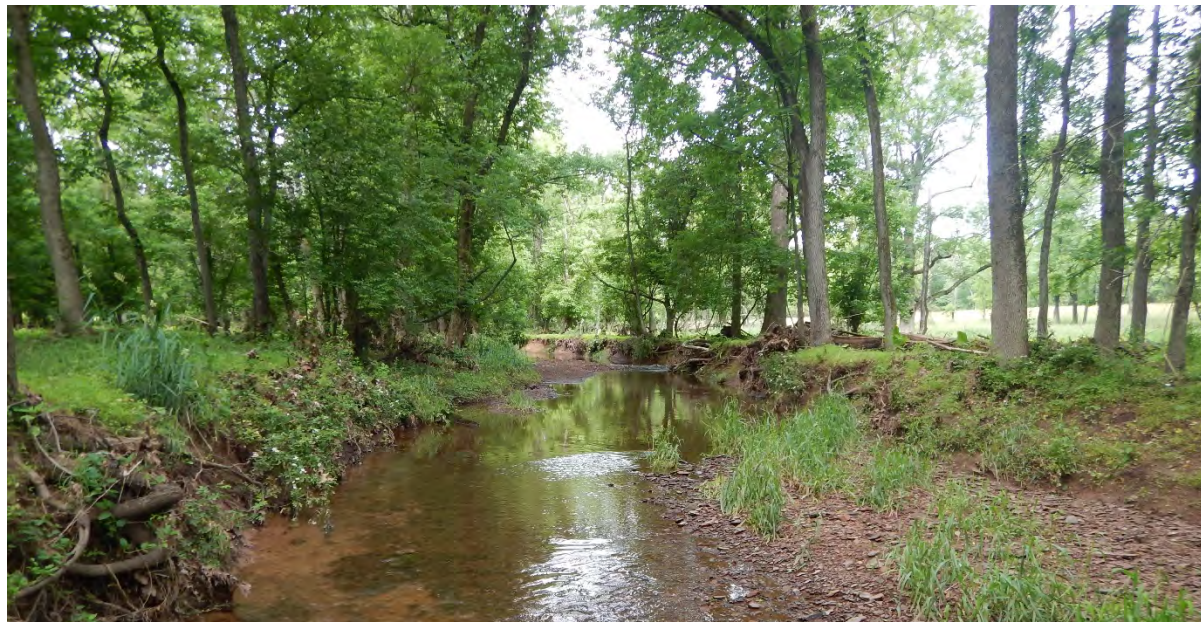
# Jericho Creek Typical Conditions

- Suburban and agricultural land with forested buffers
- Impaired Stream (PA DEP)
  - Sedimentation from streambank erosion
- Conditions:
  - Erosion
  - Highly unstable streambed and streambanks
  - Deposition issues
  - Legacy sediment downstream
  - Infrastructure issues

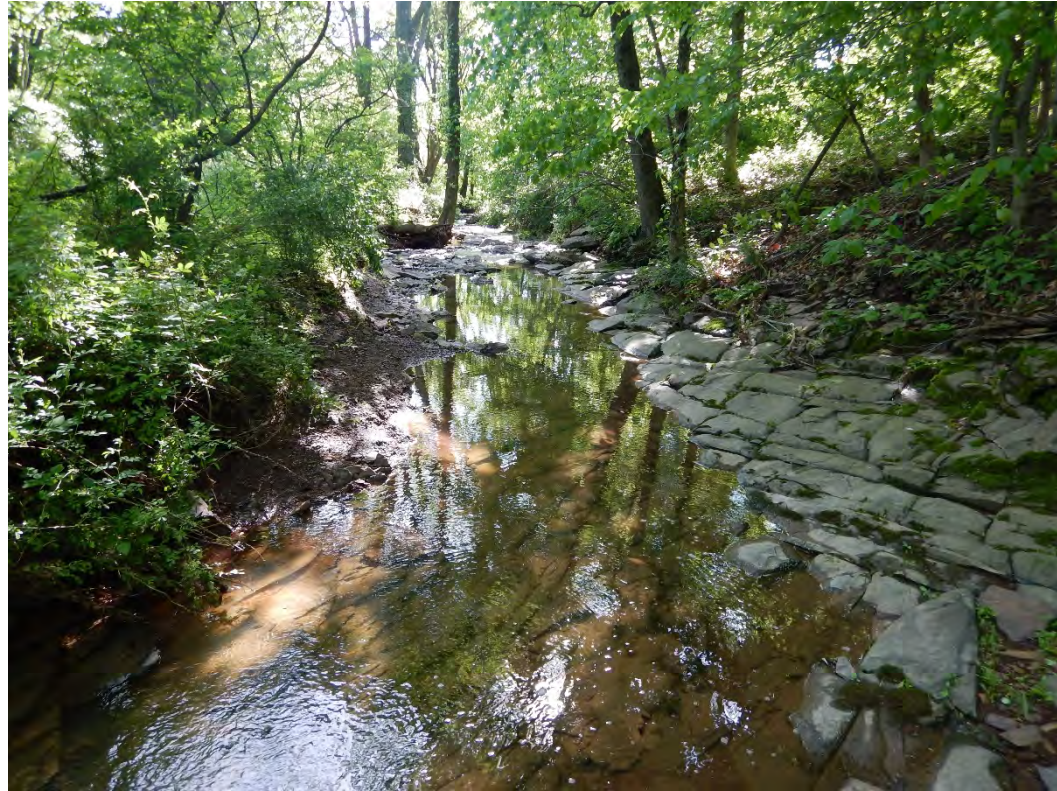
# Houghs Creek Existing Conditions

- Suburban and agricultural land with forested buffers
- More stable than Jericho because of bedrock control through much of the watershed
- Not Impaired Stream due to Sedimentation (PA DEP)
- Conditions:
  - Erosion
  - Unstable streambanks
  - Deposition issues
  - Infrastructure issues

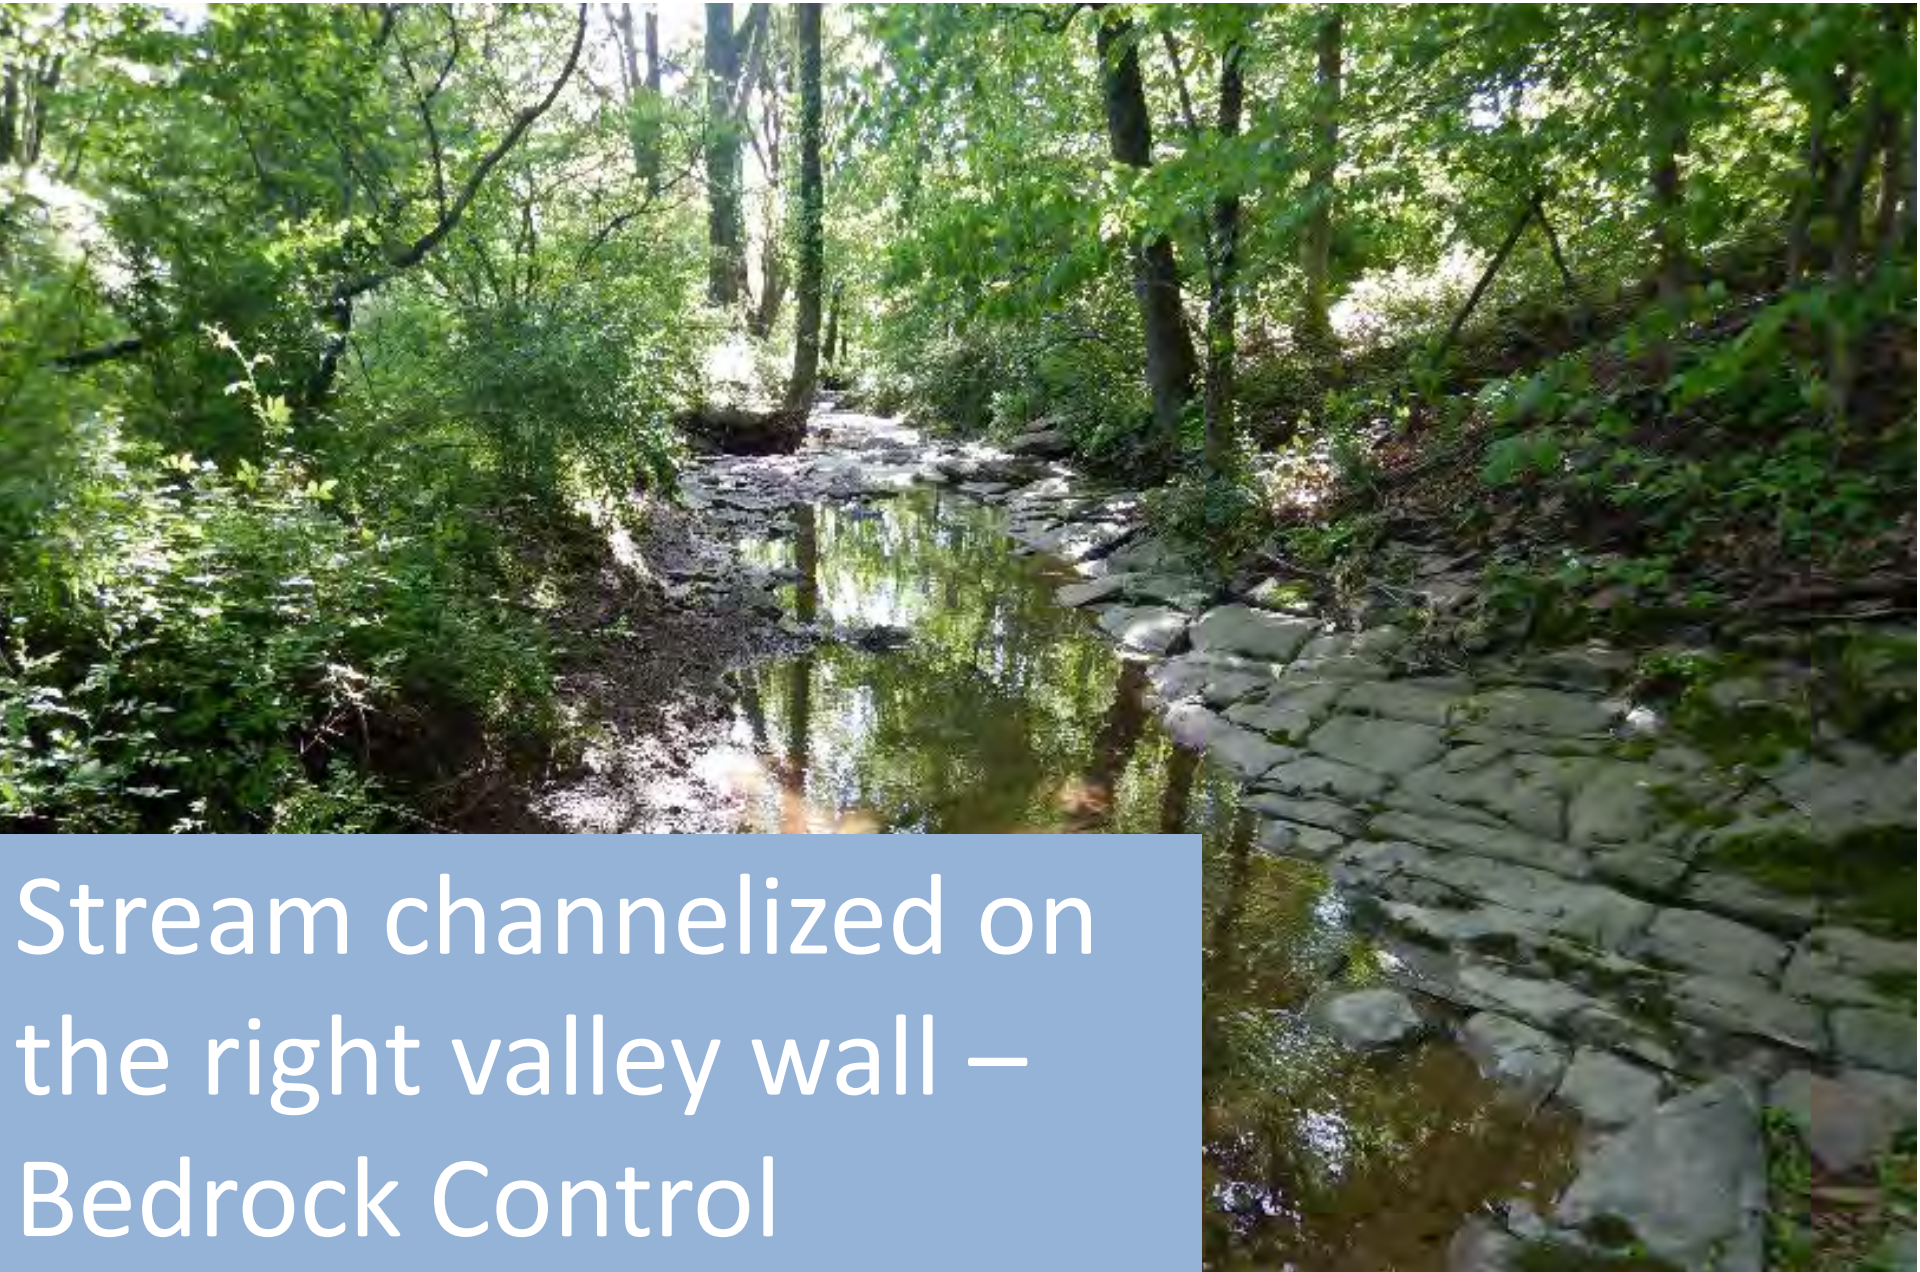
## Typical Issues – Historical Channelization

Stream channelized on  
the right valley wall –  
Bedrock Control

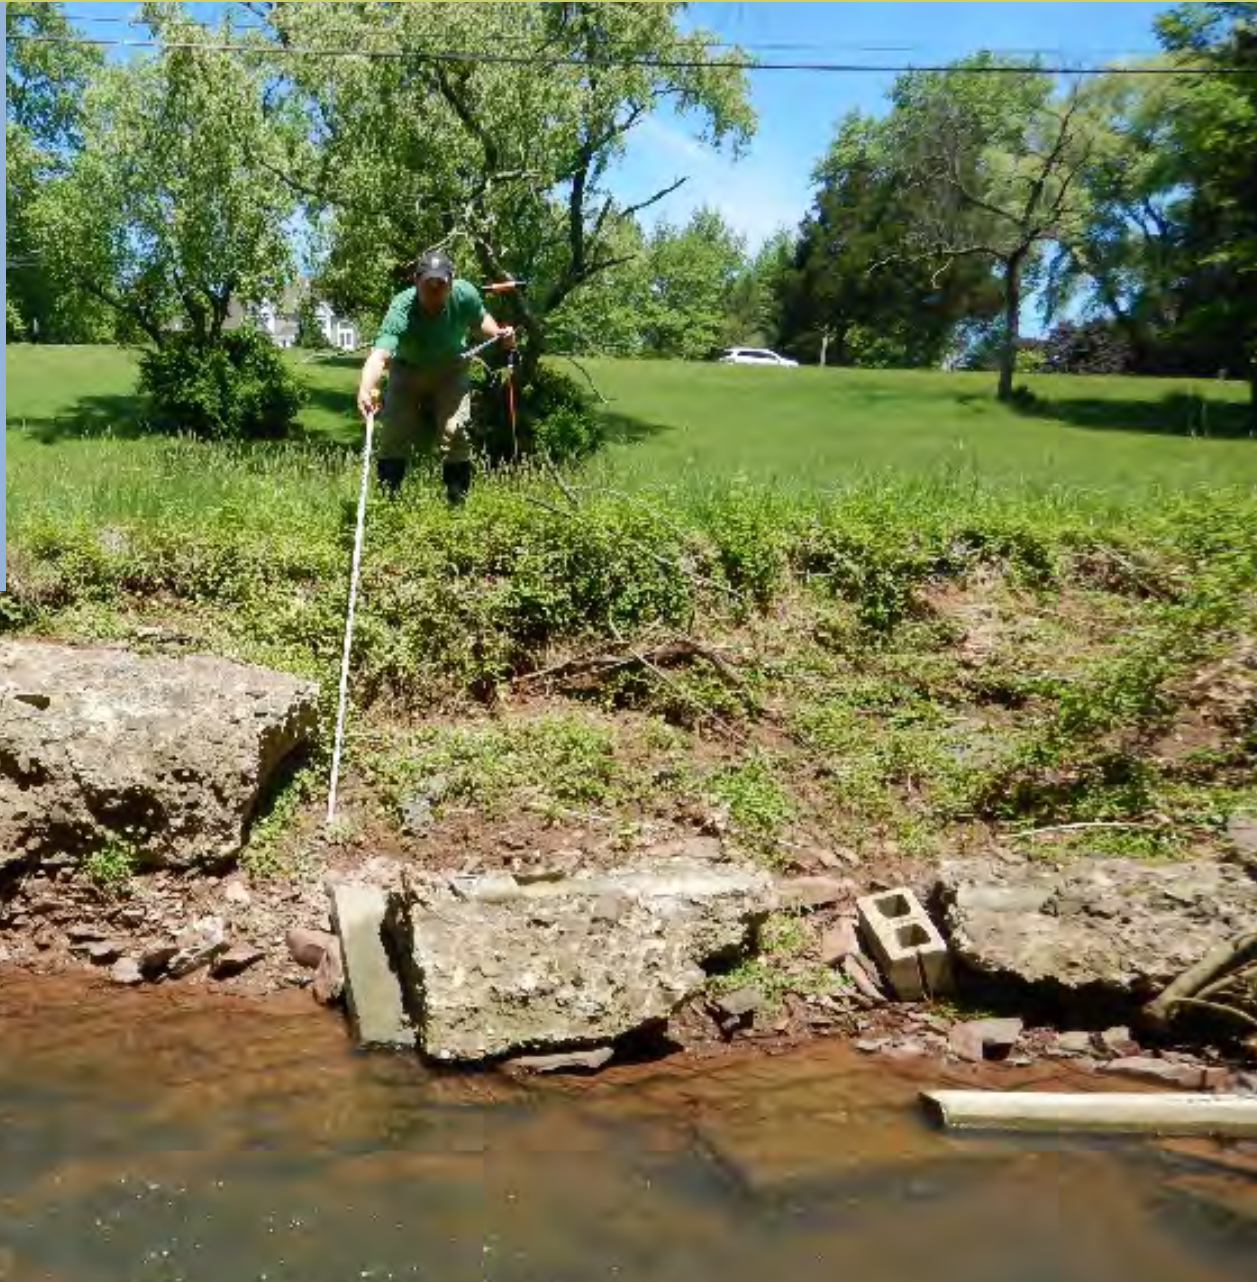
## Typical Issues – Historical Channelization

Historic  
floodplain  
terrace is 2-4  
feet

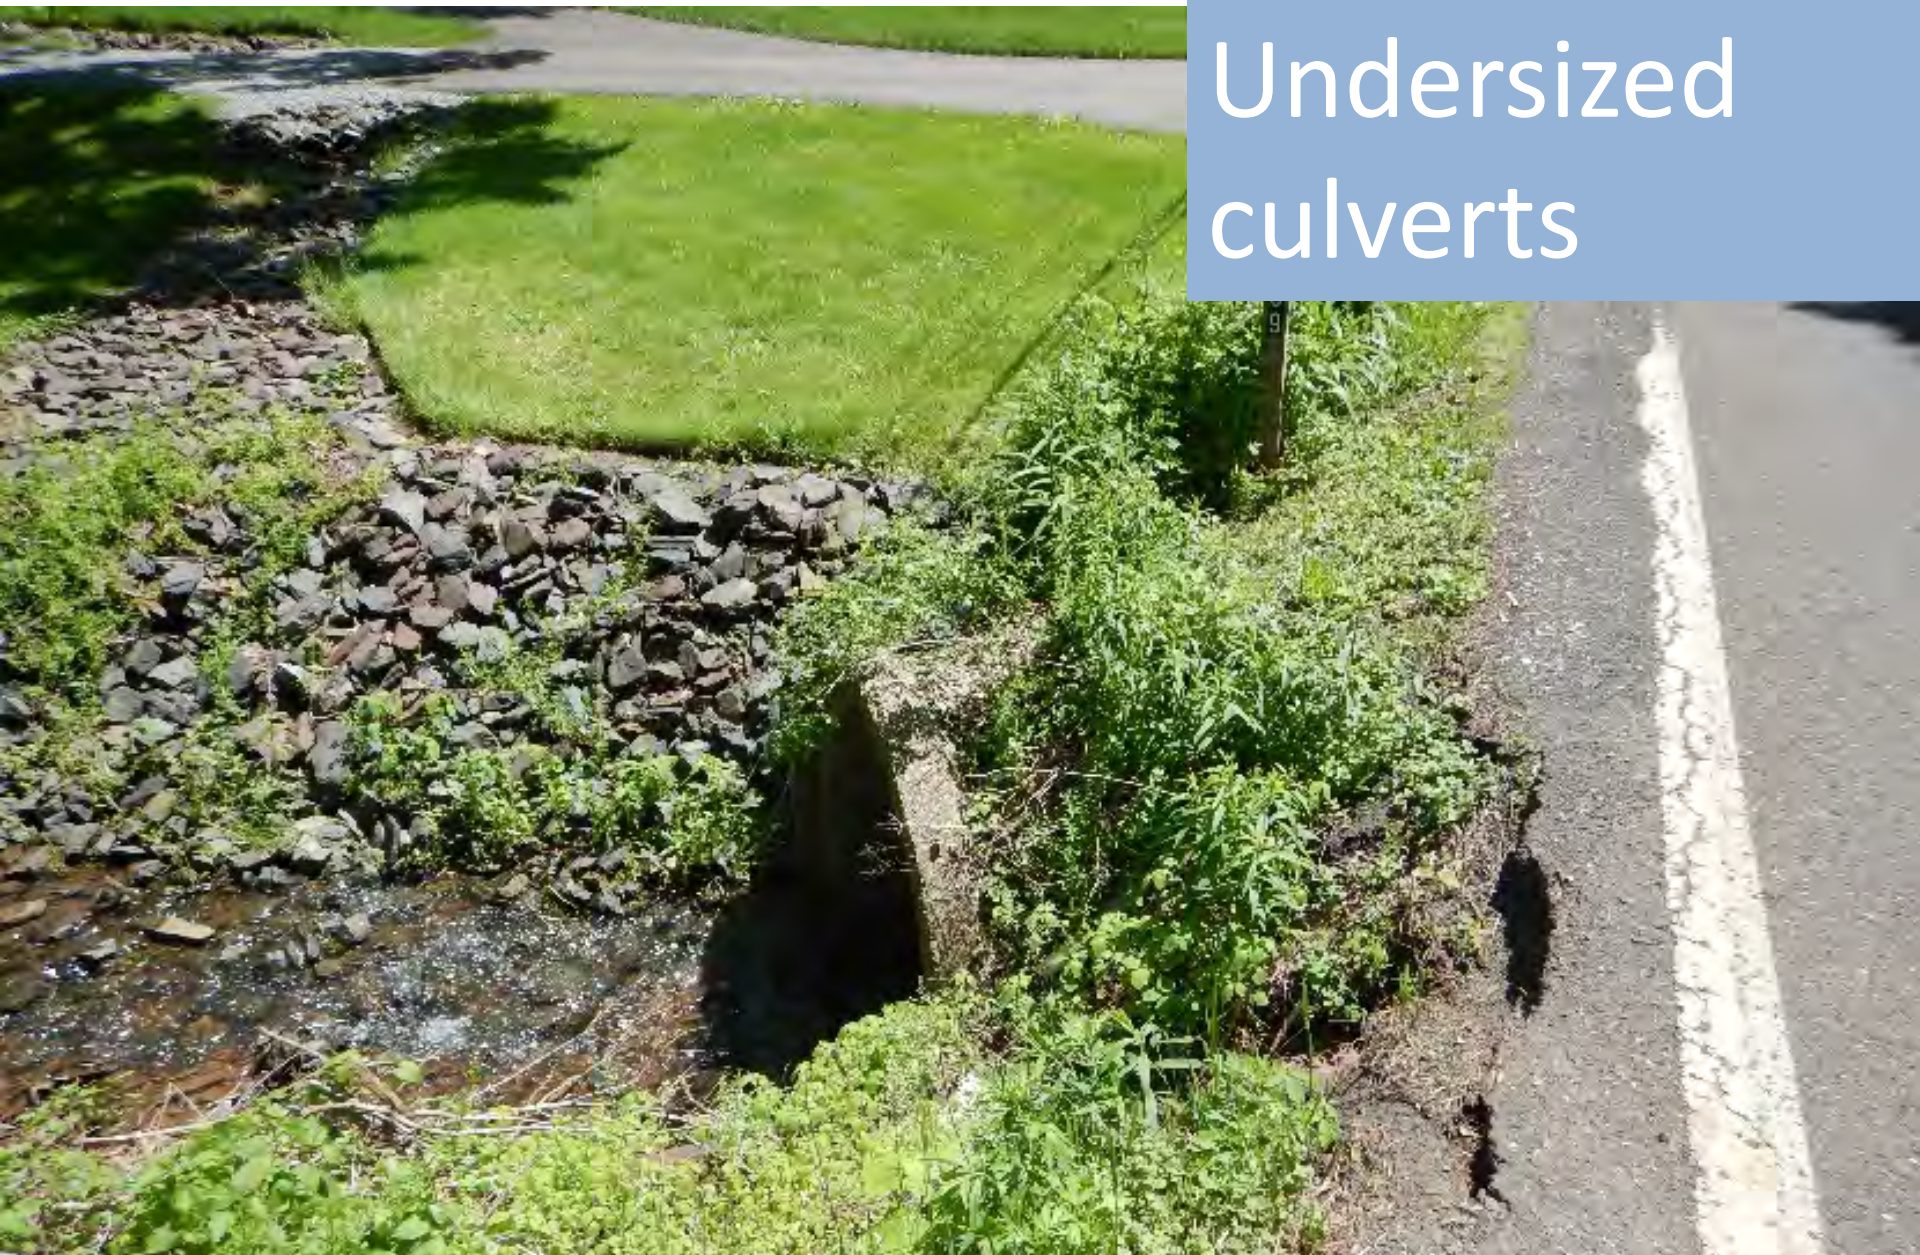
## Typical Issues – Constrictions

Undersized  
culverts

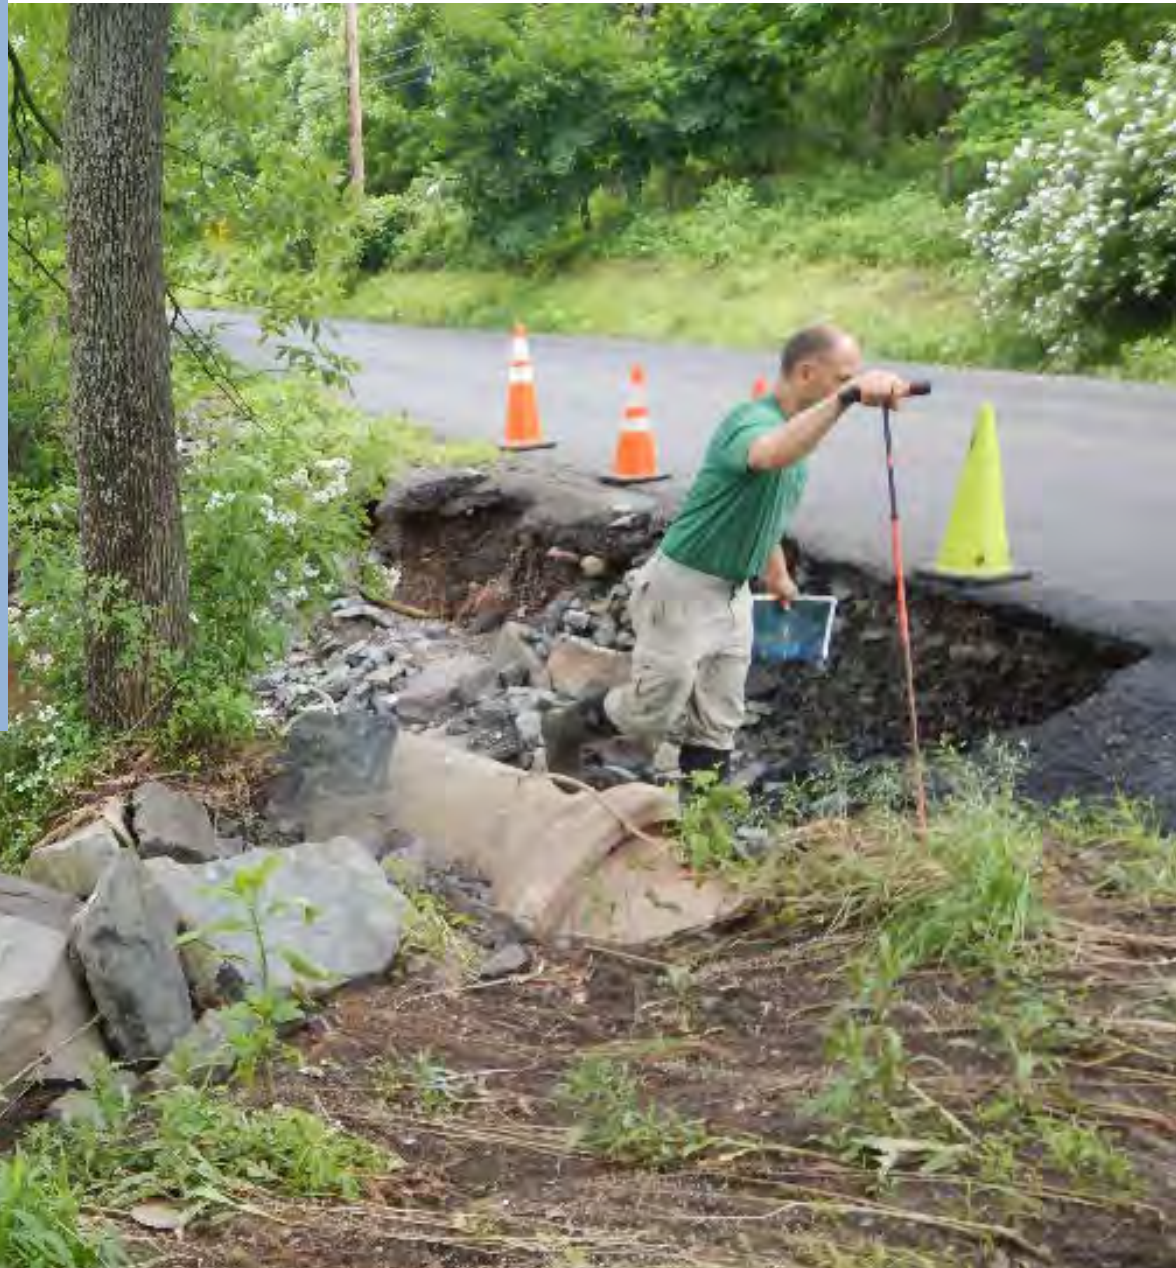
## Typical Issues – Constrictions

Overtopping  
causes  
flooding and  
loss of  
infrastructure

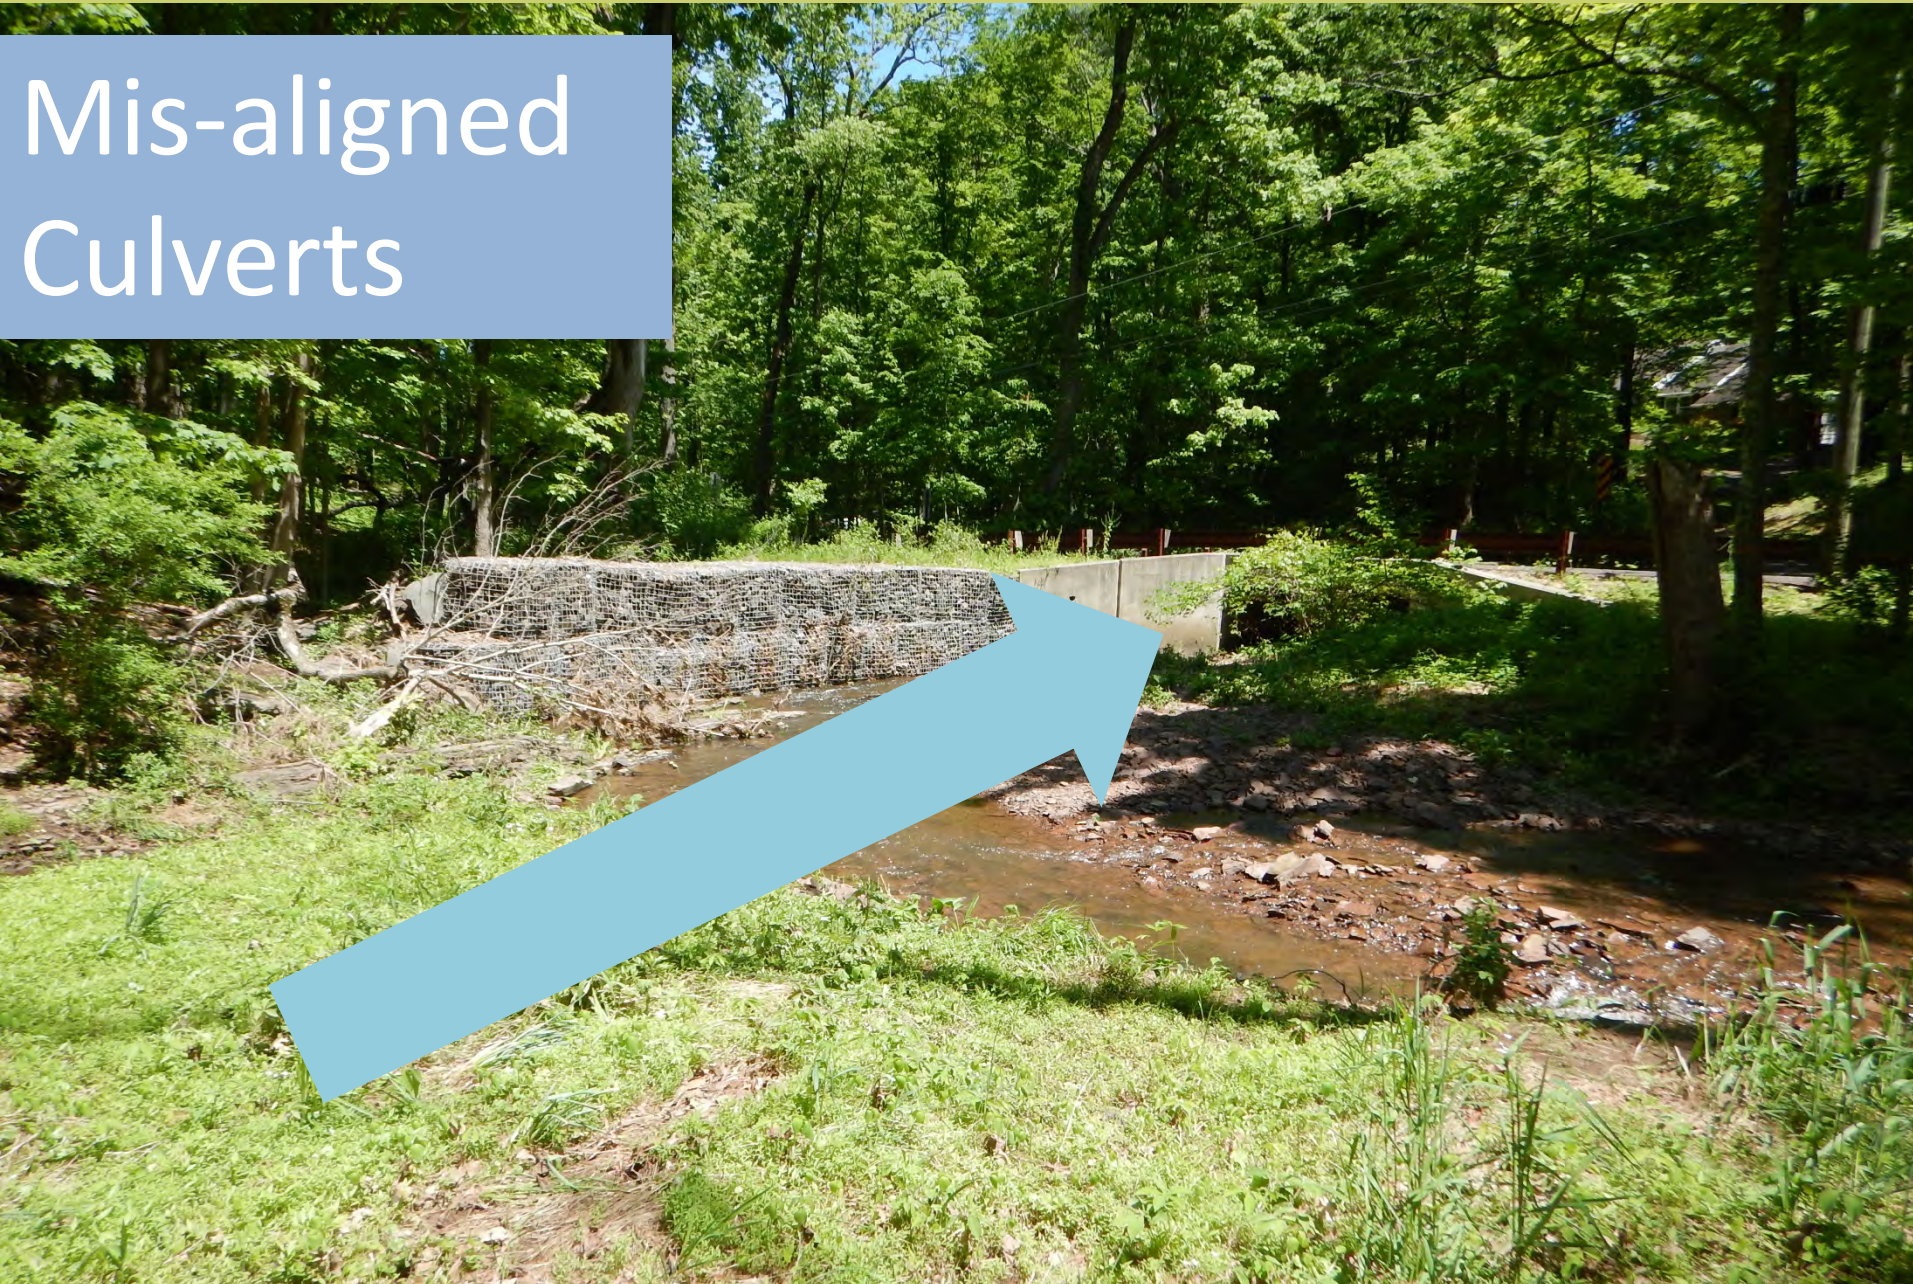
## Typical Issues – Constrictions

### Mis-aligned Culverts

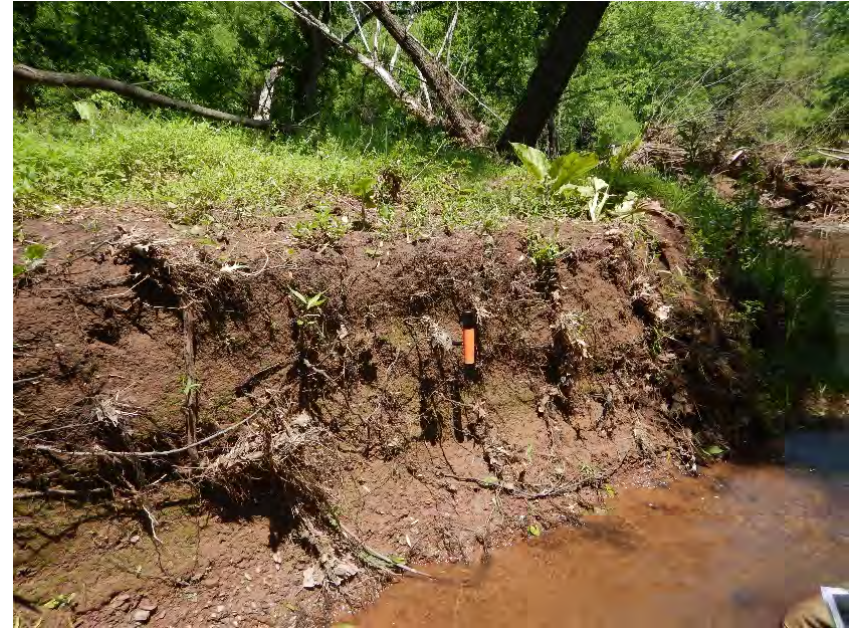
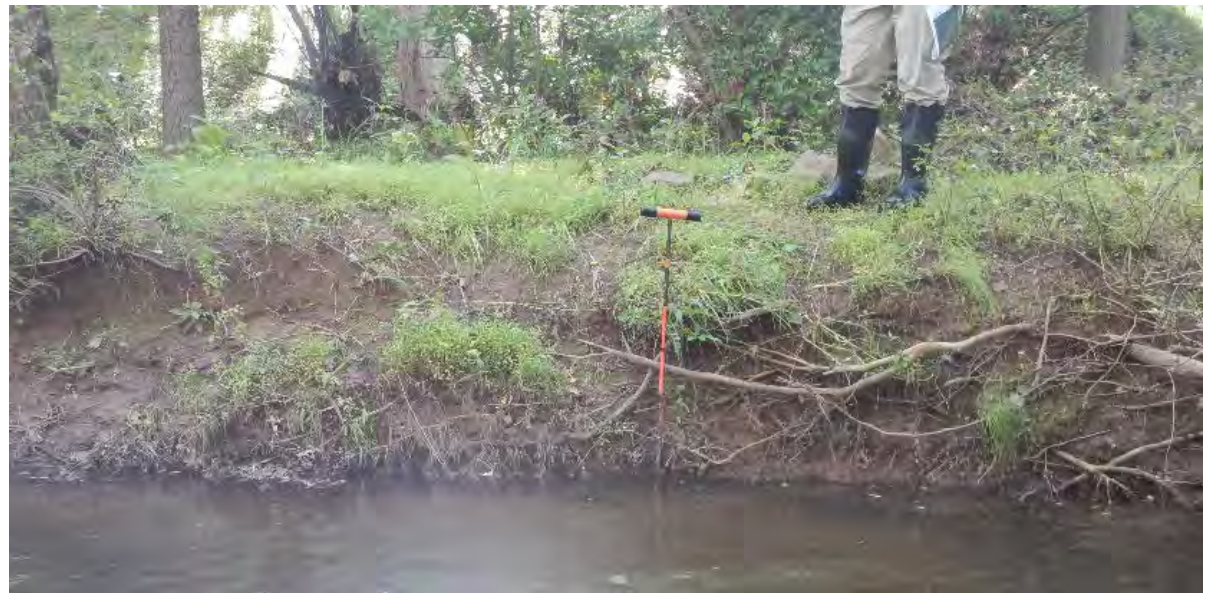
# Typical Issue – Legacy Sediment

- What is it?
  - Deposition built up behind the thousands of dams constructed during early days of settlement
  - Filled in the stream valleys as a result of forest clearing and poor agricultural practices between the 18<sup>th</sup> and early 20<sup>th</sup> centuries.
  - Results in High terraces (floodplains) and bare streambank walls.

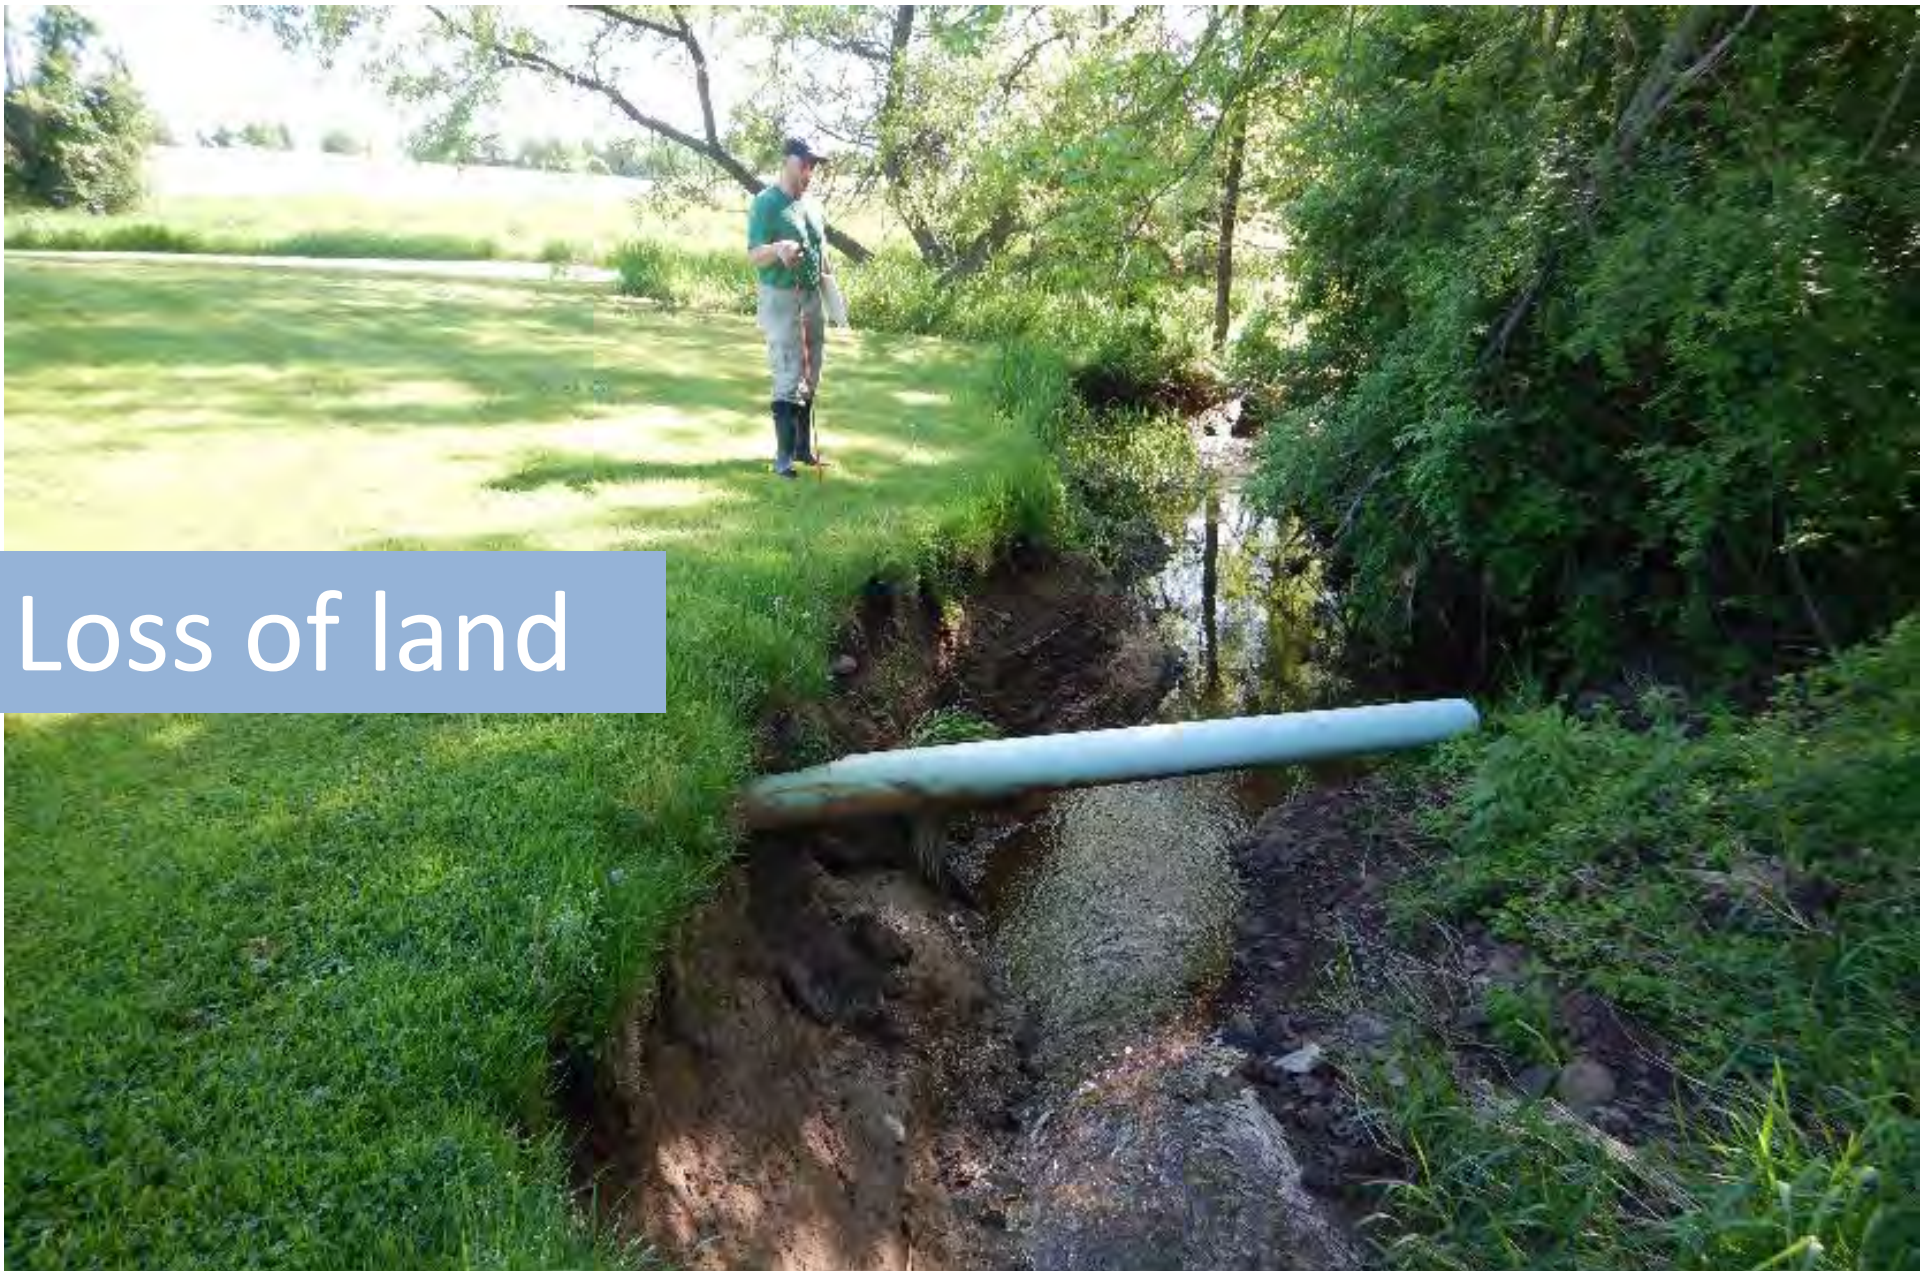
# Symptoms - Erosion and Deposition

Loss of land

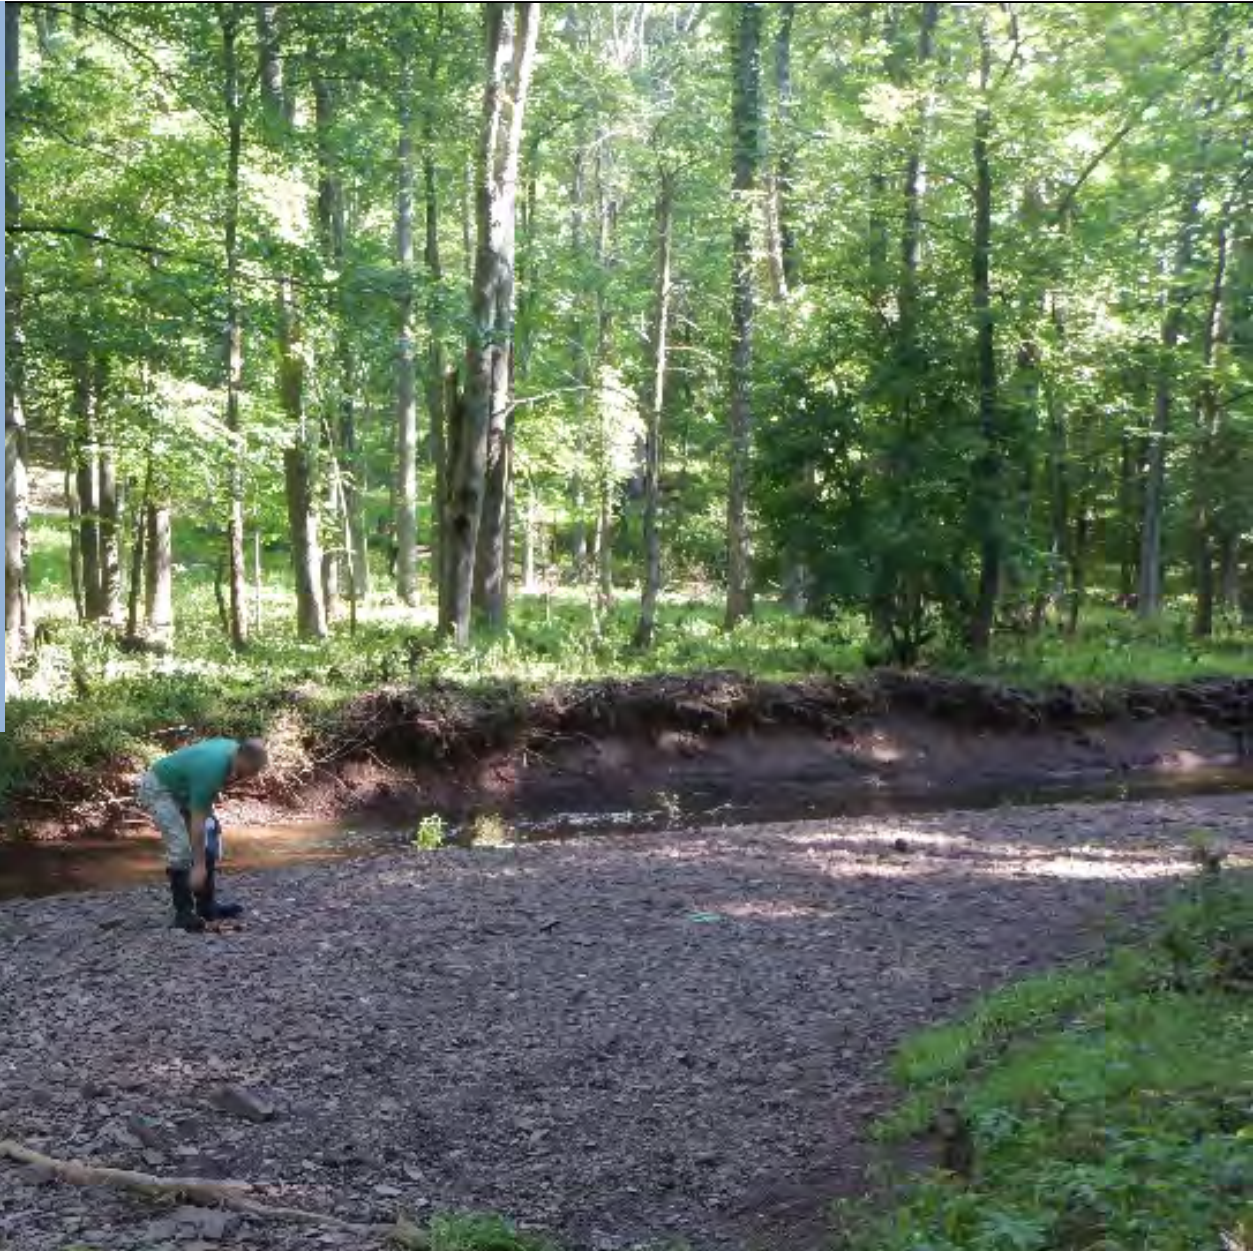
# Symptoms - Erosion and Deposition

Bedload  
movement  
contributes  
to sediment  
issues

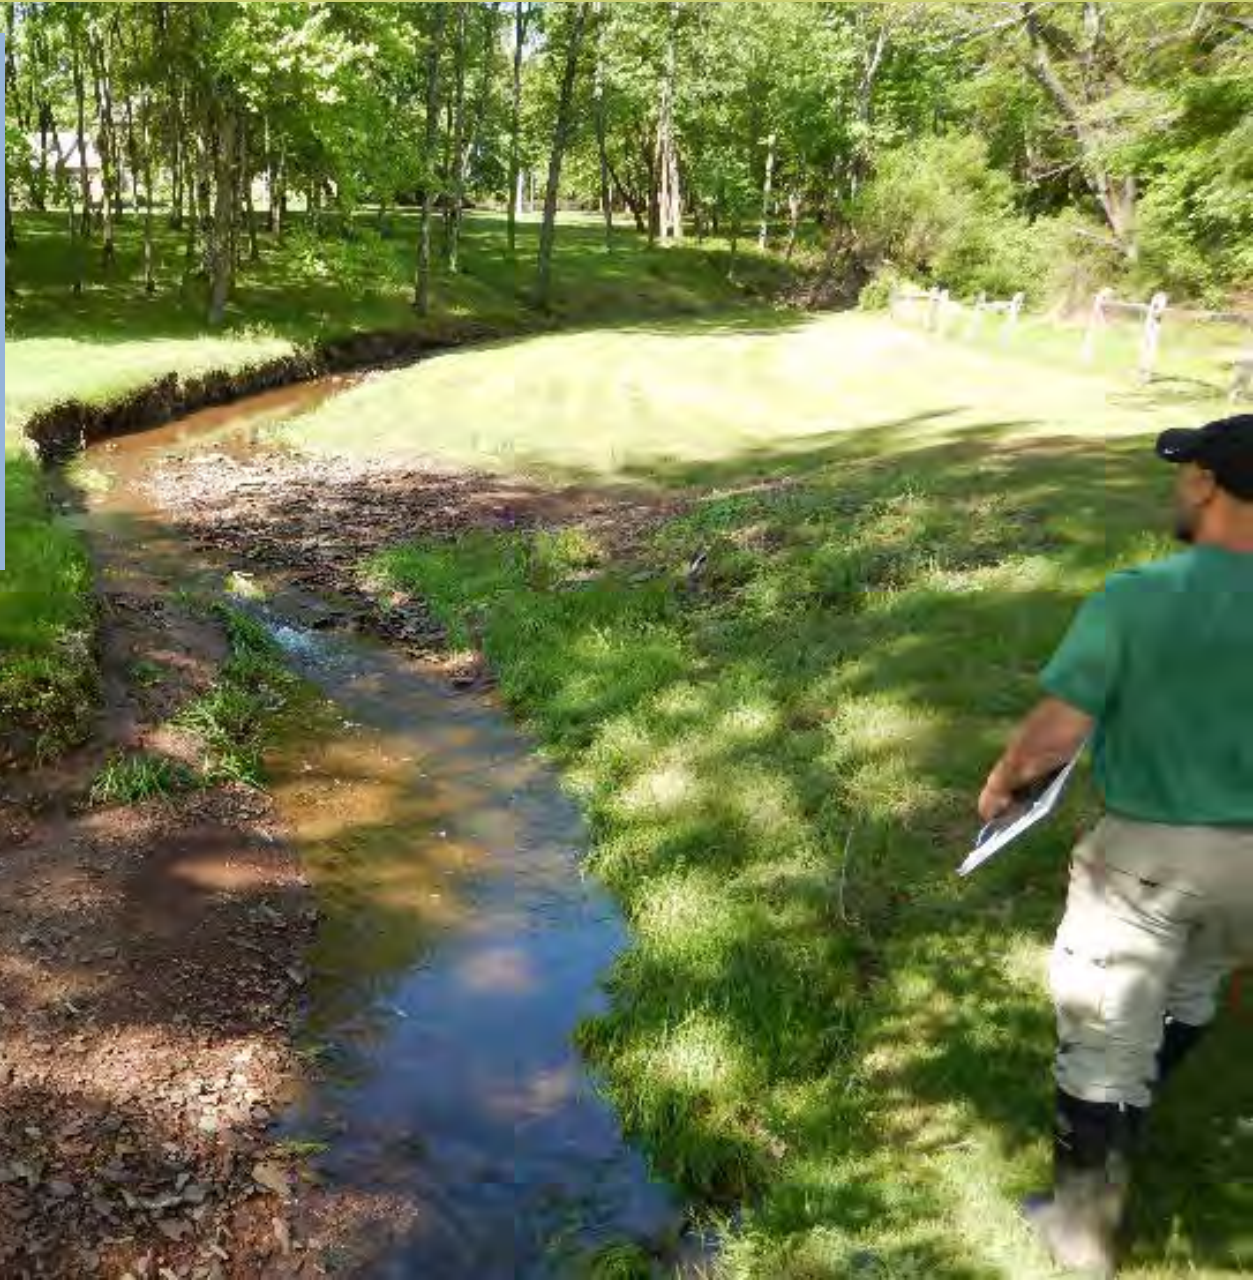
# Symptoms - Erosion and Deposition

Sediment movement through the system creates instability

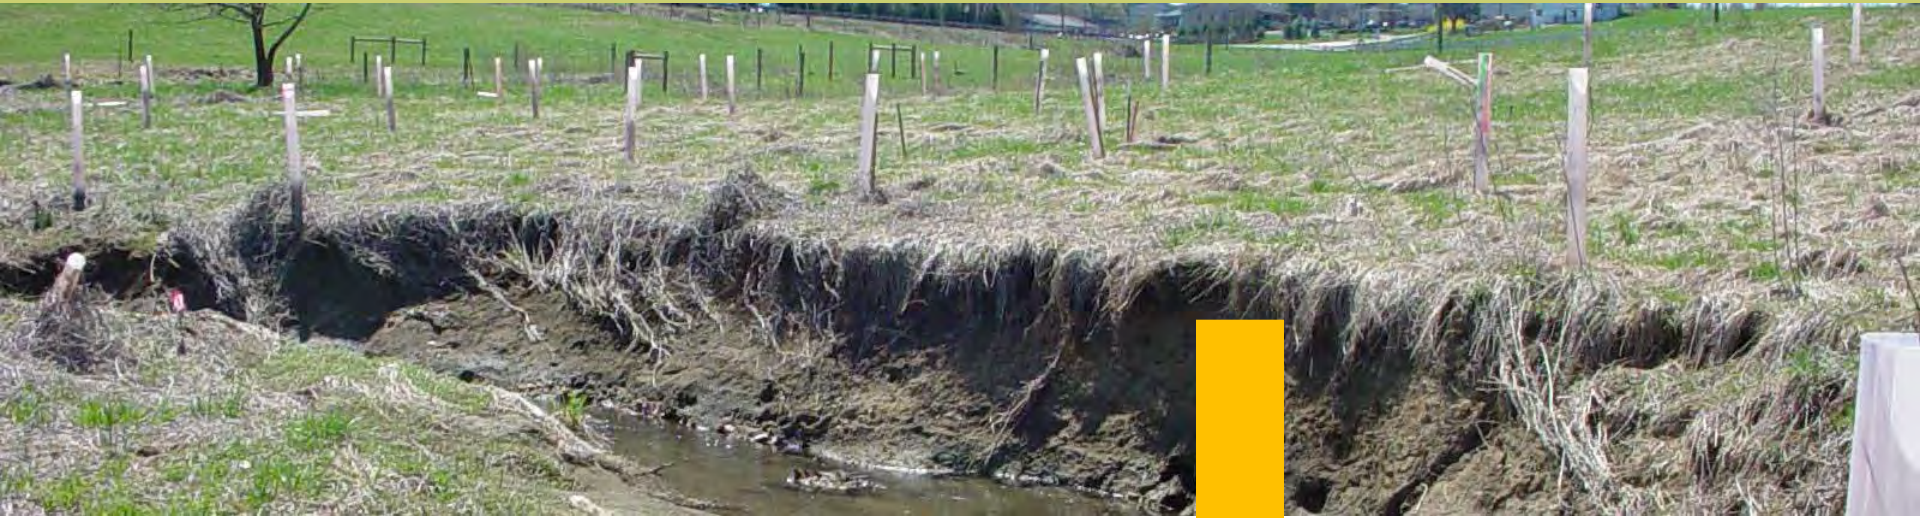
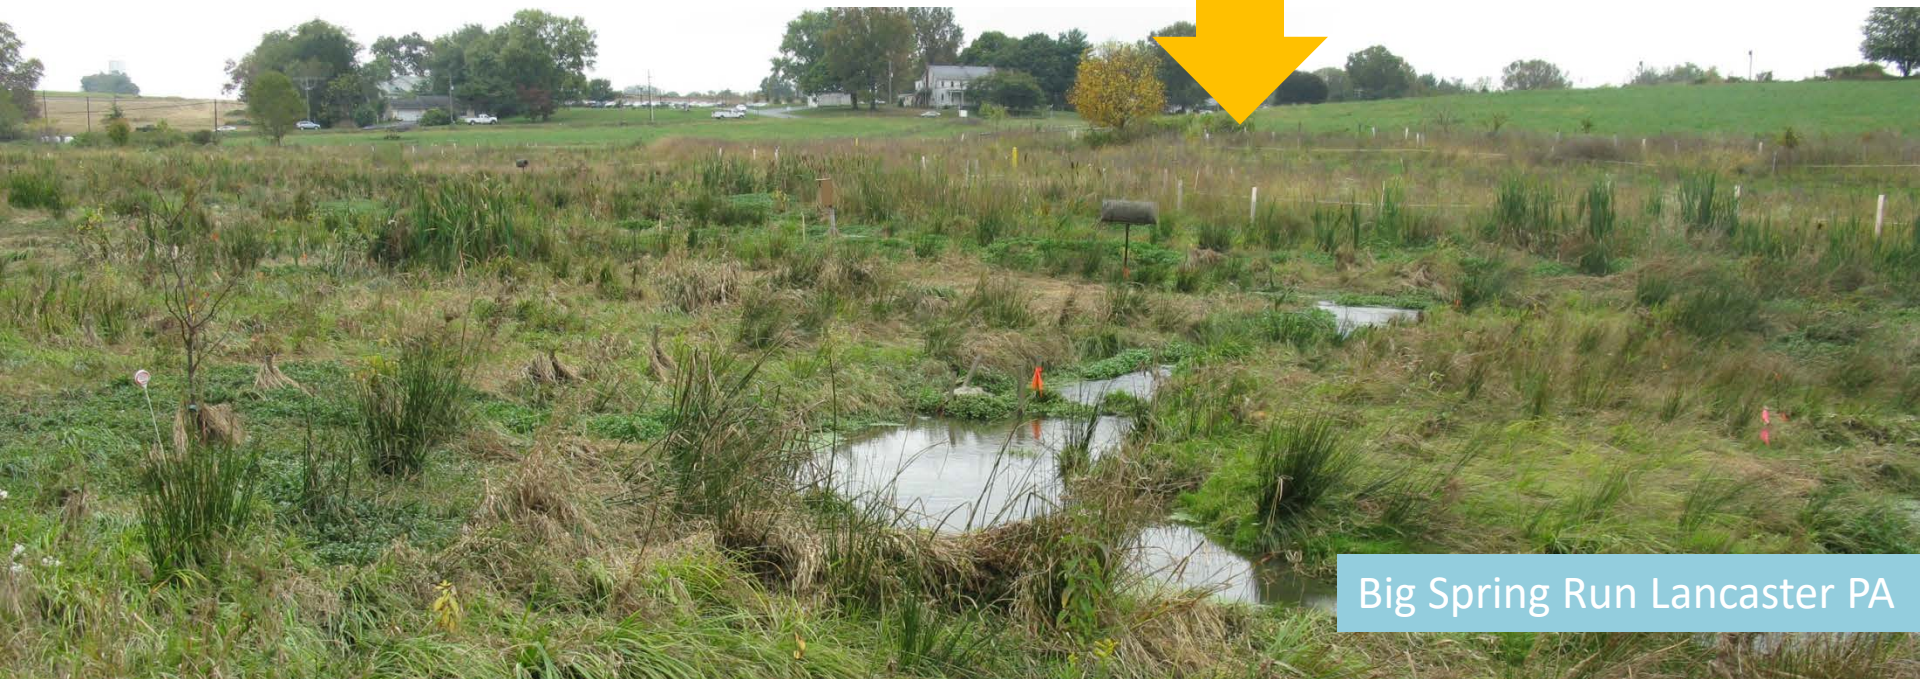
# Example Floodplain Restoration

Big Spring Run Lancaster PA
