Upper Makefield Township - Watershed Restoration Plan  
Community Workshop

09.11.2018

# Upper Makefield Township Watershed Action Plan

Community Workshop

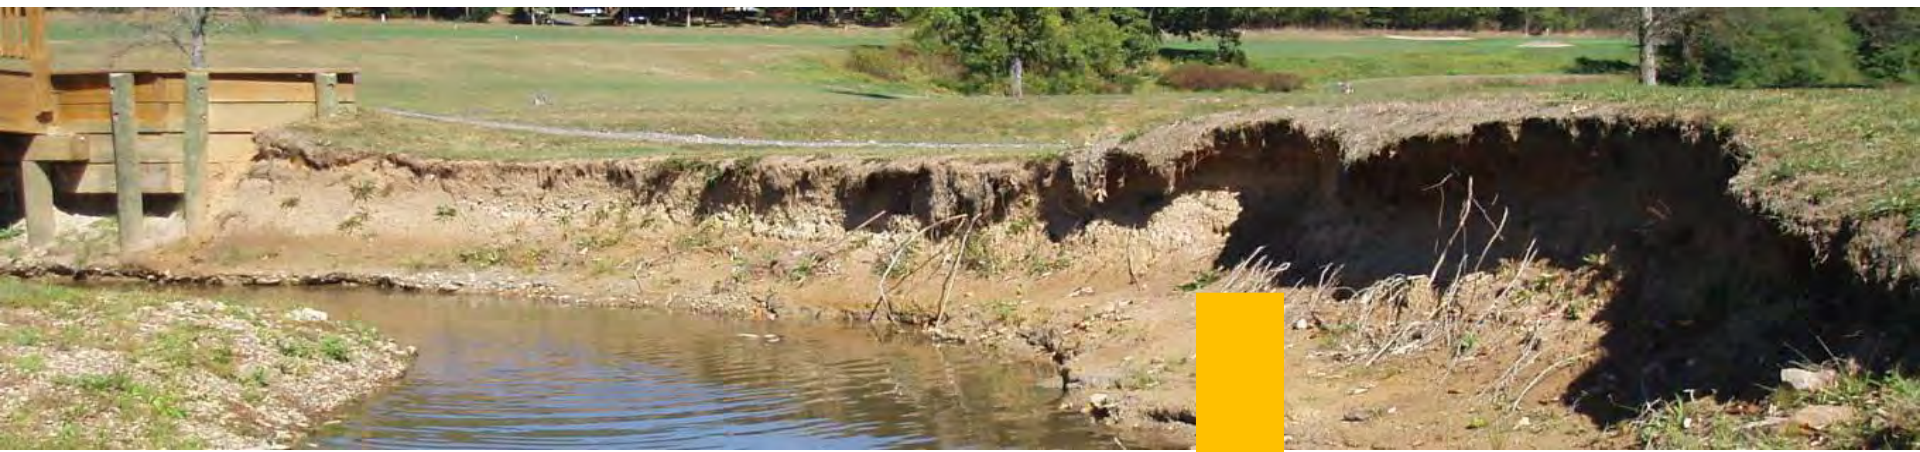
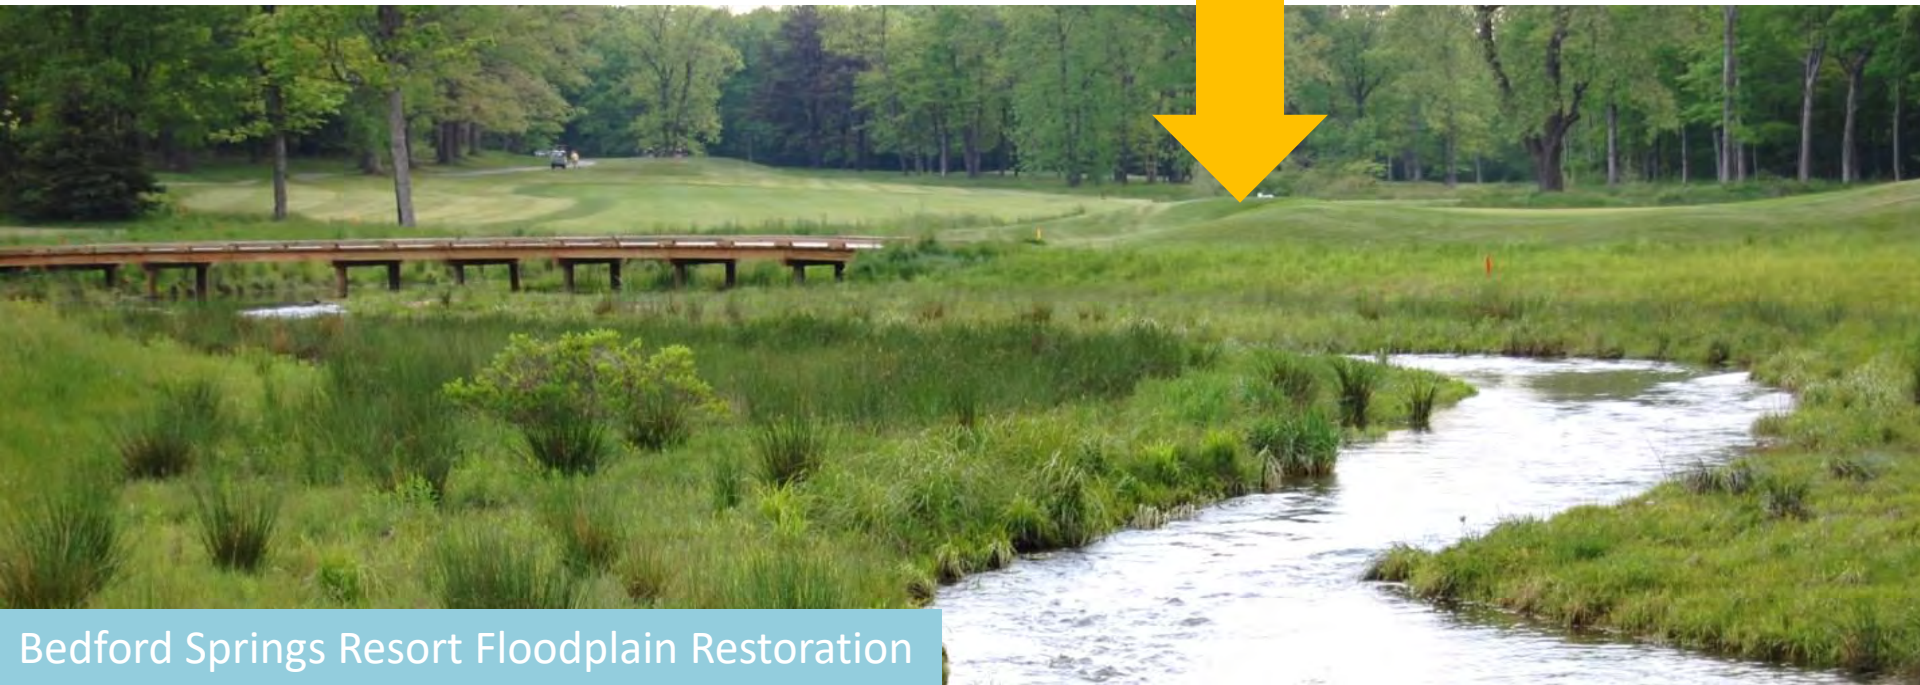
# Example Floodplain Restoration

Bedford Springs Resort Floodplain Restoration
