HERITAGE CONSERVANCY
HISTORIC RESOURCE SURVEY FORM

County Bucks **Municipality** Upper Makefield **Photo #** 4 **Tax Parcel #** 47017023

Address / Location 1790 Lindenhurst **Resource Name** Dolington Hist Dist **National Register Status** listed

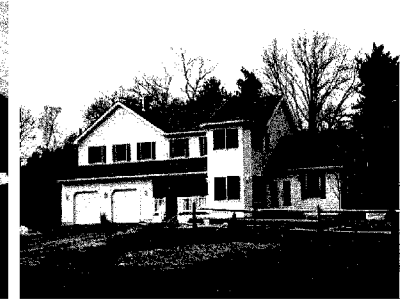
Rear view

Notes:
 Wood frame with vinyl siding & replacement vinyl windows. Part 1: 3 bay, double pile, gable roof, pedimented entry, 2.5 story. Part 2: 2 bay, gable roof, 2.5 story, attached at gable end to part 1. Part 3: 1.5 story, 2 bay, gable roof. On rear of parts 1 & 2 is a 2 bay garage & porch that share the same shed roof. On the rear of part is is a projecting, 2.5 story, hip roof addition. Integrity of house is very poor, if any historic fabric remains at all.

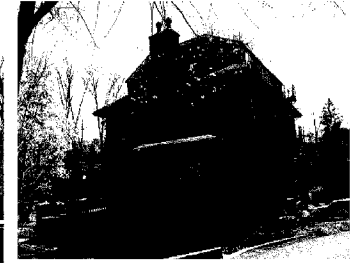
Rear view

Notes:
Stone, 2/5 story, 5 bay, double pile, 2 stone interior end chimneys, hip roof, attic has been raised 1 story to accommodate apartment conversion, single story hip roof wings on either side, large front porch/patio, roman arches over doors, jack arches over windows, sash windows, 10 light casement windows.

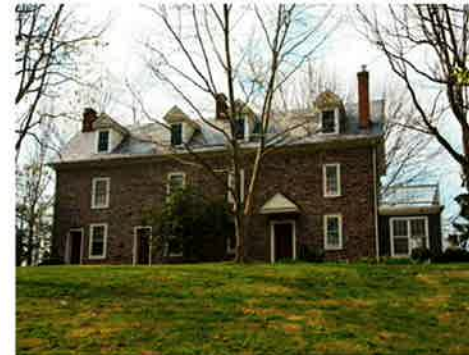
Street elevation

Main block: stone 2.5 story, 3 bay, single pile, 2 brick interior chimneys, gable roof, 2 gable roof front dormers, relieving arches over first floor 6/6 windows, pedimented hood over primary entrance. **Addition:** stone, 2.5 story, 4 bay, single pile, 1 brick interior end chimney, gable roof with two gable roof dormers, 6/6 windows.

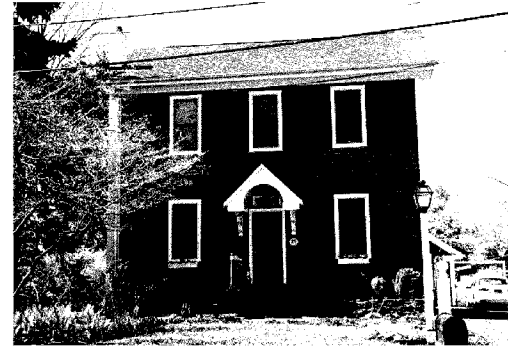
Front elevation

Wood frame with wood clapboards, gable roof, 2.5 story, 3 bay, single pile, 1 brick interior end chimney, 1 masonry exterior end chimney, concrete block foundation, replacement vinyl 1/1 windows, 1/2 attic windows, 1 attic window has diamond panes, wood frame additions to rear, pedimented entry porch

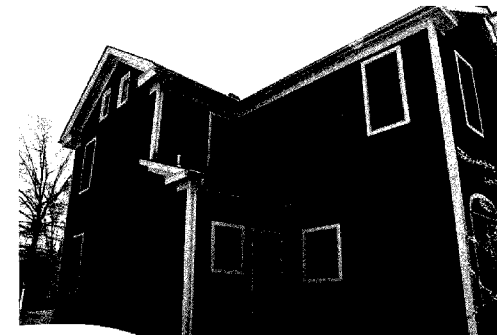
Rear view with additions & main block

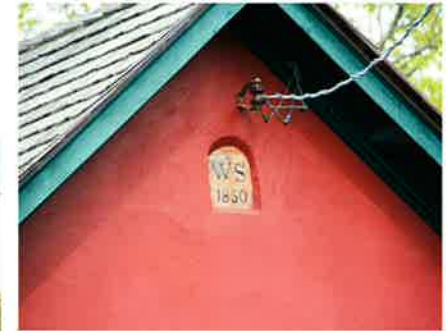
Datestone

Historical Notes:
 Constructed by Joshua Smith, datestone reads "1850 WS"

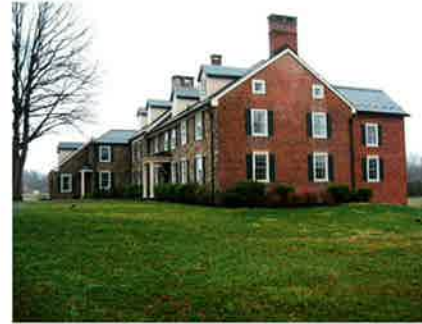
House with brick and stone walls

Notes:
 1781 brick section is Flemish bond; features back-to-back corner fireplaces, jack arches over door and windows, and king post truss roof support; 1825 stone addition is 3 story on south side and 2.5 story on north side; one stone end chimney that connects to a cooking fireplace and one brick interior chimney for a heating fireplace; first floor: 9/6; second floor: 6/6.

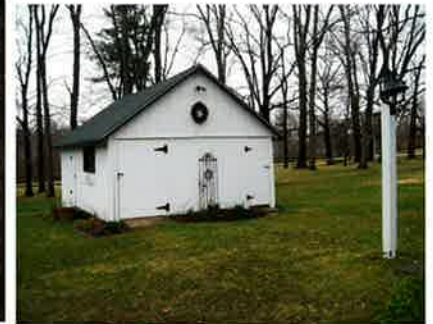
Garage

Notes:
Garage: wood frame with vertical siding, 1.5 story, 2 bay, 6 light windows, gable roof. Bank barn: Burned, stone ruins still in place with rebuilt frame stabling which is clad in board & batten siding.

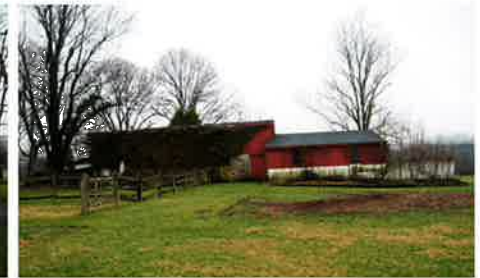
Barn ruins with rebuilt stabling

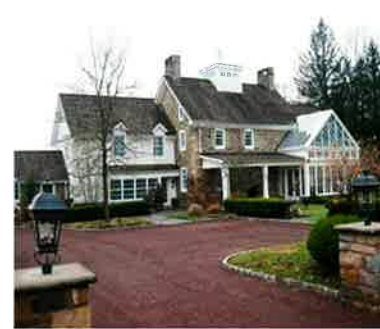
Front view

Notes: Stone main block with numerous frame, masonry & glass additions. **Main Block:** 3 bay, 2 pile 2.5 story; 6/6; wood shingle, gable roof; 2 large interior end chimneys; flat roofed belvedere added to center of roof shed roof front porch over 2.5 bays with tuscan order support columns. **Additions:** *Part 1:* 1 story, 1 bay, wood shingled gable roof, field stone construction; *Part 2:* Stuccoed masonry, 2.5 bay, wood shingled gable roof, 8/8 windows; raised seam metal roof bay window with covered entry incorporated, 1/2 dormers with gable breaking the cornice of main roof but window itself below cornice line. *Part 4:* glass "greenhouse" addition attached to and partially overlapping main block and masonry, gable roofed addition, glazed gable roof.

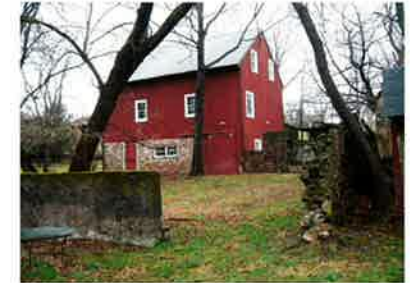
Barn 1 with ruins

Notes:
 Timber and stone barns: Barn 1 burned down so current structure is a rebuild but remains of previous structure were preserved and incorporated into new, traditionally built barn. Barn 2 is original to property, is in good condition and has initials inscribed on wood work.

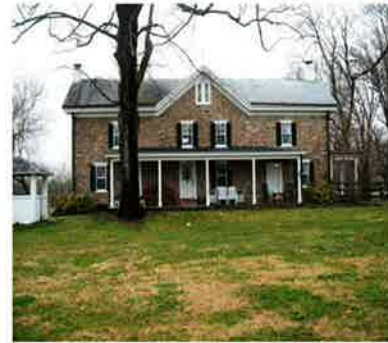
Front elevation

Main block: Envelops a stone 2.5 story, 2 bay, older stone house; overall is 2.5 story, 6 bay, single pile, gable roof with central cross gable, 1 interior end chimney, 1 exterior end chimney, 2/2 windows, returning cornice. **Addition 1:** extends perpendicularly from main block, stuccoed masonry, raised seam metal gable roof, 1 exterior end chimney. **Addition 2:** Single story shed roof masonry addition to rear with side entry.

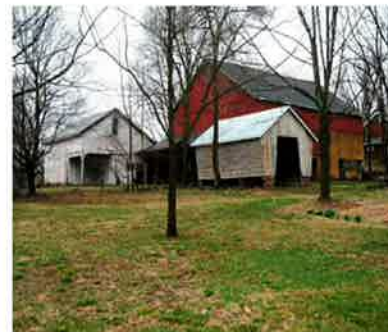
Outbuildings

Barn: Stone stabling with timber above, gable roof vertical siding, earth ramp; **Carriage house:** wood frame with vertical siding, 2.5 story, 2 bay, gable roof, side shed roof addition; **Chicken house:** Wood frame with vertical siding condition is very poor; **Spring house:** banked, stone ruin condition; **Tenant house:** Wood frame with shingle cladding, 2.5 story, 3 bay, single pile, 1 brick interior end chimney, 1 masonry exterior chimney, gable roof, 6/6 windows, one bay shed roof addition & 2 bay gable roof addition, both single story. Overall condition of all outbuildings is quite poor.

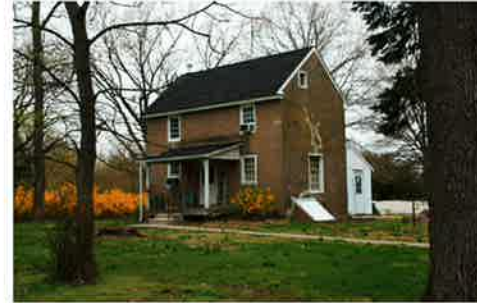
Notes:
Stuccoed stone, 2.5 story, 3 bay, single pile, 1 stone interior end chimney, gable roof, 6/6 windows, 1 bay porch surrounds primary entry, rear frame addition.

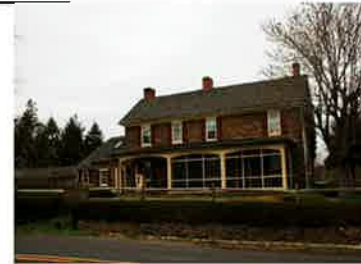
Street elevation

Notes:
 3 part. Part 1: small, 2 bay, single story frame addition with gable roof & clapboard siding. Part 2: stone construction, 2 bay, single pile, gable roof, 1 brick internal end chimney, 6/6 windows. Part 3: shares a gable roof with part 2, 3 bay, single pile, 2 brick interior end chimneys, 6/6 windows, a large shed roof triple dormer added to the back of the gable roof. A partially enclosed porch with a hipped roof runs along the front of parts 2 & 3.

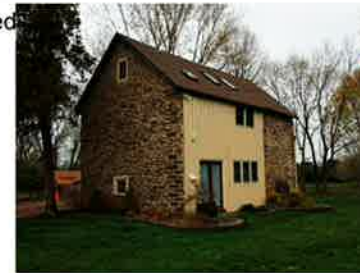
Barn

Notes:
Wagonhouse: gable roof, 1.5 story, 3 bay with hayloft access in gable peak. Barn: converted to living space, stone construction with a central vertical board clad section, gable roof, 4 bay, 2.5 story.

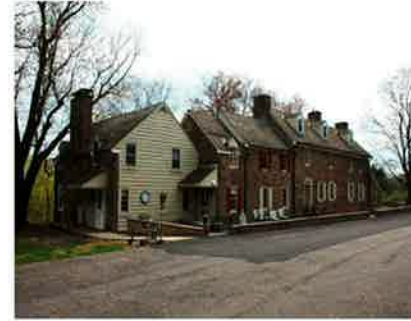
House & outbuildings

Notes:
Main block: stone, 2.5 story, 2 bay, single pile, gable roof, 1 stone interior end chimney, 1 gable roof dormer, 9/6 first floor windows, 6/6 second floor windows, stone shed roof kitchen extends from 1 gable end. Additions: Stone 2.5 story, 3 bay, single pile, 2 stone interior end chimneys, gable roof, 2 gable roof dormers, 9/6 first floor windows, 6/6 second floor windows, 4 light transom over primary entry door, 3 later additions built in mid-late 20th century have strong relationship to design elements of older parts of the house.

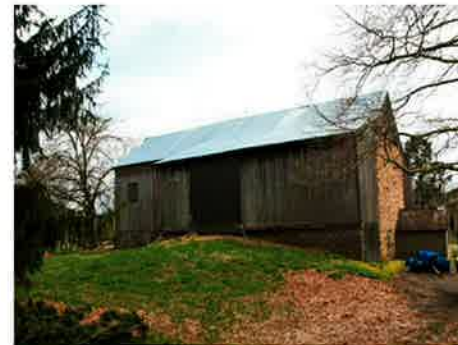
Bank barn

Notes:
Bank barn: stone stabling with stone above, frame gable roof, closed forebay & frame forebay, earth ramp, metal gable roof, barn was doubled in width during the late 19th century, masonry milk house extends from gable wall. Wagonhouse: stone with frame eaves, 2.5 story, 3 bay, gable roof, converted to living space above. Springhouse: banked, stone, gable roof. Smokehouse: stone, 1.5 story, 1 bay, single pile, gable roof. Corn crib: double drive through plan, wood frame with vertical siding, gable roof

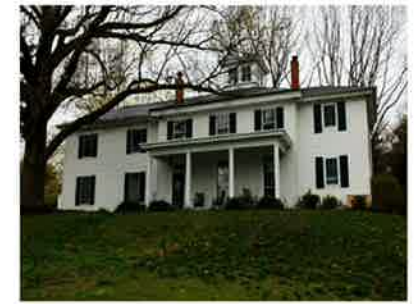
Rear & side view

Notes:
Part 1: wood frame, clapboard siding, 2 bay, 2 story, hipped roof, brackets visible in eaves, 2/2 windows. Part 2: main block, wood frame construction, hipped roof, central belvedere with paired arched windows, 6/6 windows, 2 brick end chimneys, visible brackets in eaves, flat roofed 3 bay front porch. Part 3: wood frame construction, single bay, hipped roof, brackets visible in eaves, 6/6 windows.

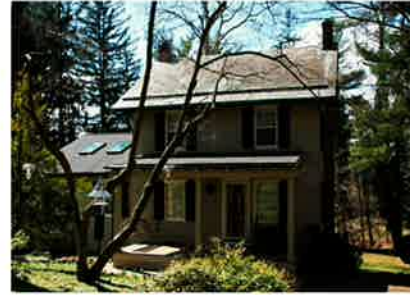
House (front elevation)

Notes:
 Wood frame with shingle siding, banked, 2.5 story, 3 bay, double pile, 1 stone exterior end chimney, 1 brick exterior end chimney, gable roof is bracketed, shed roof porch over front entry has a shed roof over a pergola-style frame, 6/6, second story porch has been enclosed.

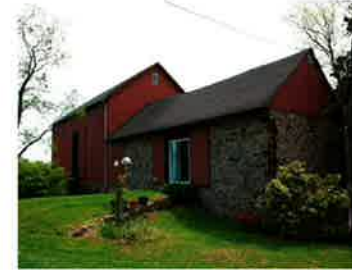
Front view

Notes:
Barn is associated with house at 318 Pineville Rd., has been partially converted into tenant housing, 2.5 story, 3 bay, gable roof, stone stabling with frame above & vertical siding.

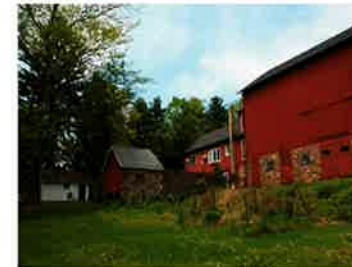
Rear view with shed & smokehouse

Notes:
Shed: wood frame construction, gable roof.
Smokehouse: stone with gable roof & vertical siding on one gable end.

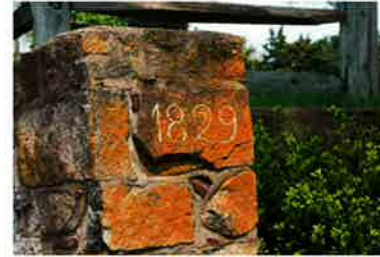
Datestone

Notes:
 Modern house built incorporating barn ruins associated with #355 Pineville Rd. ruin wall that encloses driveway is a datestone that reads "1829"

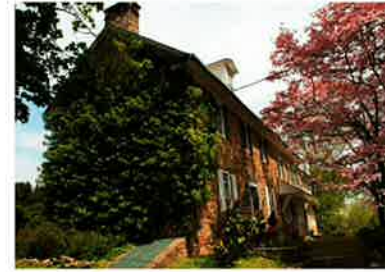
Front view

Notes:
Westerly section is stone construction, 2.5 story, 3 bay, single pile, 1 stone interior end chimney, datestone reads: "BSW 1787"; Center block is stone construction 2.5 story, 3 bay, single pile, 1 stone interior end chimney, a pent eave spans the south elevation, datestone is only partially legible & reads: "187"; The third block is stone construction, 2.5 story, 2 bay with a datestone that reads: "JAB 1932"

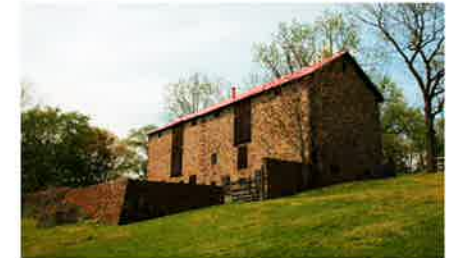
Street view (from east)

Notes:
 This stone bank barn was built in 2 sections. The westerly section of the barn was built in 1807 with yellow, brown and buff field stone with some red & blue shale. There are pronounced red sandstone quoins on all 4 corners. There is a wood frame vestibule on the western gable end, and a full height frame shed on the northerly facade. Upon the construction of the easterly section in 1835, the roof of the first section was raised to form a continuous ridgeline. The gable roof is covered in metal. The newer section of the barn was built in stone. it abuts the eastern end of the older section and therefore has quoins on the eastern end only. The northerly elevation has a frame, gable roof bridge house connecting the main barn to the earth bank.

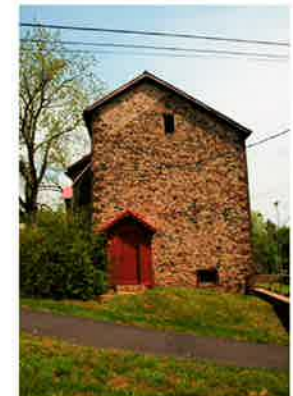
The building is significant for its association with the Wiggins family and architecturally, is and extremely large and well designed barn. The barn was built in 2 sections, each of which have a datestone, 1807 & 1833, respectively. The 1807 date has the initials of B & M W (for Benjamin & Mary Ann Wiggins). Thier initials also appear on the house in the adjoining property at 367 Pineville Rd. This Benjamin Wiggins was the son of the Benjamin Wiggins whose initials appear on the house at 355 Pineville Rd.

Western end (with change in roofline evident)

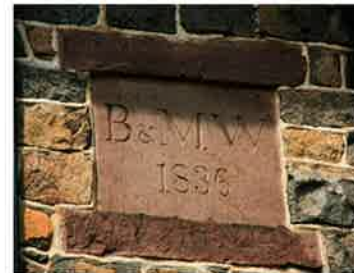
Datestone

Initials on datestone are for Benjamin & Mary Ann Wiggins. Their initials also appear on the barn at 359 Pineville Rd. This Benjamin Wiggins was the son of the Benjamin Wiggins whose initials appear on the house at 355 Pineville Rd.

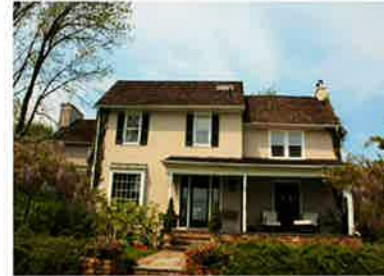
Front elevation

Notes:
 3 part: 1 bay, 2 bay, 1 bay; gable roof, 2 external end chimneys; 1 story entry porch extends from part 2 across part 3; on front between parts 1 & 2 is a sunroom addition with flat roof; part 2 has a projecting, shed roof dormer on first floor; modern perpendicular gable roof addition extends from rear.

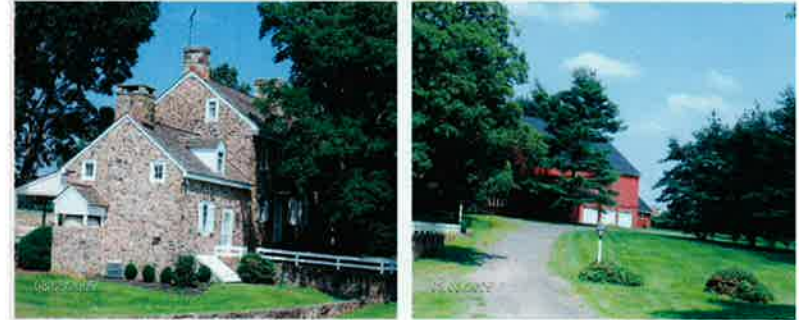
Notes:
Main block: Stone cabin, 1.5 story, 2 bay, single pile, one stone interior chimney, exterior bake oven support with frame gable roof, gable roof, rear wood frame porch, 6/6, front & rear gable roof dormers. **Addition:** 1769 datestone on rear in an articulated alcove, stone, 2.5 story, 4 bay, single pile, 2 stone interior end chimneys, gable roof, 6/6, arched window openings, 2 gable rear roof dormers. **Addition:** stone, 2.5 story, 2 bay, single pile, gable roof, 6/6, grilled window openings, 1 gable roof rear dormer. **Addition:** wood frame with clapboards, 1.5 story, 1 bay, gable roof, 6/6.

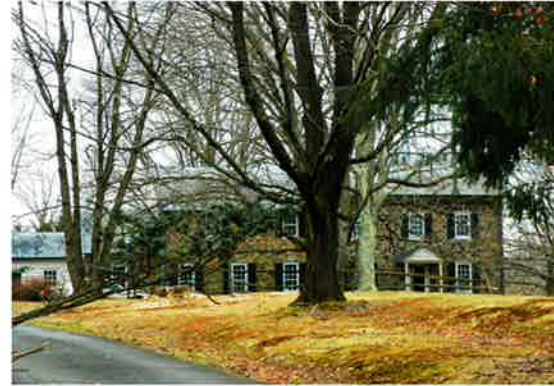
Notes:
Main block: Stone 2.5 story, 3 bay, single pile, 2 stone interior end chimneys, gable roof; side Stone 2.5 story, 3 bay, single pile, 2 stone interior end chimneys, gable roof

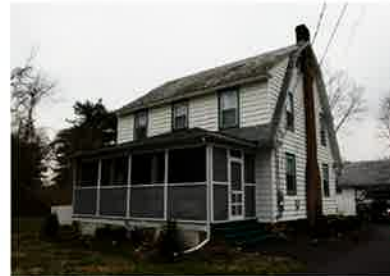
Street view

Notes:
Wood frame on a "cinder block" foundation, clapboard siding, 2.5 story, 3 bay, double pile, 1 brick exterior chimney, slate gambrel roof, front & rear shed dormers, screened front porch, 6/1 windows, rear entry vestibule.

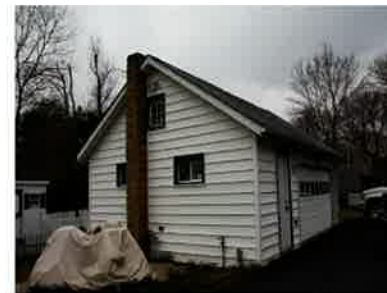
Garage

Notes:
Wood frame with clapboards, 1.5 story, 2 bay, single pile, 1 concrete block exterior chimney, slate gable roof, 1/1 windows.

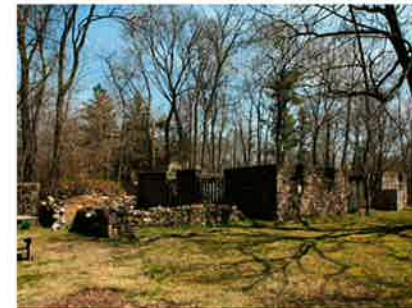
Ruins of outbuildings

Foundation remains of bank barn & connected haybarn; foundation for ice house adjoins root cellar.

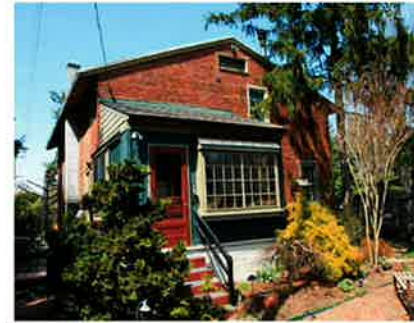
Front (driveway) view

Notes:
Common bond brick, 1.5 story, 3 bay, single pile, gable roof, altered fenestration, double row headers set in segmental arches above original window openings, frame, enclosed, shed roof porch addition to driveway elevation, small, pedimented entry porch over door on street elevation, 6/6 windows (replacement).

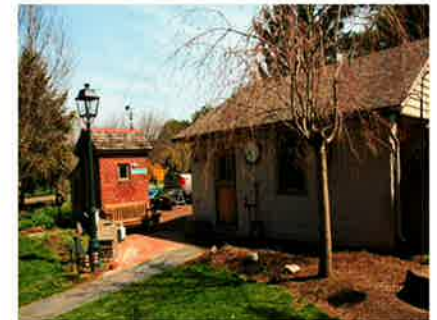
Garage & privy

Notes:
Garage: rusticated concrete block, 1.5 story, 3 bay, gable roof;
Privy: brick, gable roof

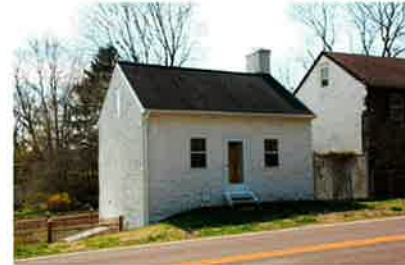
Front view

Stuccoed, masonry, banked house, on the street elevation, the structure is 1.5 stories, 3 bays, gable roof, two masonry interior chimneys, windows are 1/1 replacements, a frame, 2 bay, shed roof porch is located at the basement level on the rear of the house.

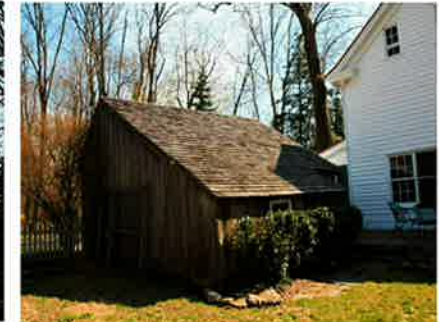
House (rear view) Wagonhouse

Wood frame with board & batten siding, 1.5 story, 2 bay, salt box roof.

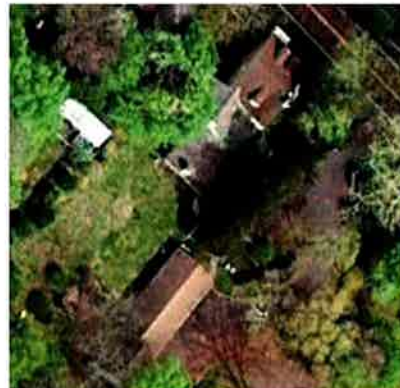
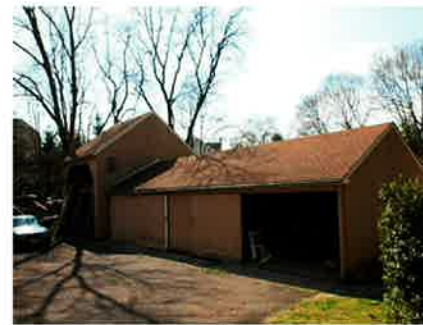
Garage / wagonhouse

Frame construction, 1 taller 1.5 story gable roofed single bay adjoining 3 wide single story bays.

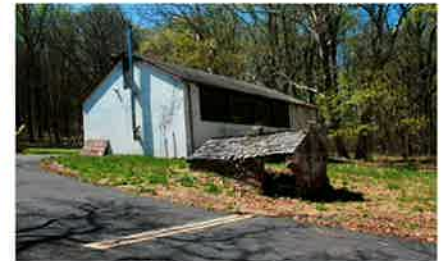
Modern barn & historic springhouse

Notes:
Stuccoed masonry with gable roof-- in very poor (near ruin) condition.

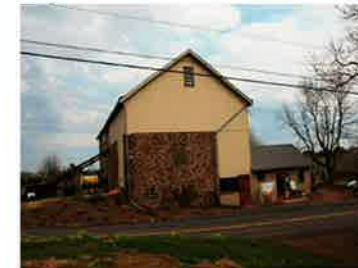
Bank barn (earthen ramp at left, milk house at right)

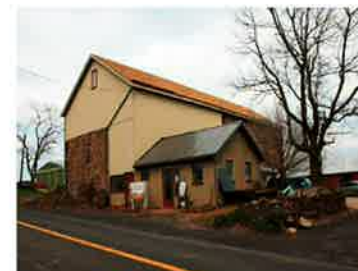
Milk house (foreground) & bank barn

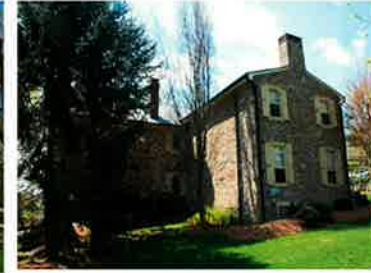
Main block & addition

Notes:
Main block: stone, 2.5 story, 3 bay, single pile, 2 stone interior end chimneys, gable roof, 9/6 first floor windows, 6/6 second floor windows, 2.5 story "L" with raised seam metal gable roof extends from rear and is partially stuccoed, a reconstructed concrete bake oven extends from stuccoed gable wall. **Addition:** stone, 2.5 story, 2 bay, single pile, 1 stone interior end chimney, slate gable roof, 9/9 first floor windows, 6/6 second floor

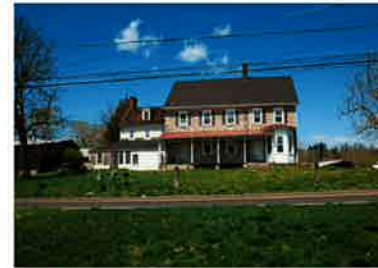
Front elevation

Main block: stone & stucco, 2.5 story, 3 bay, single pile, 1 brick interior end chimney, metal gable roof, 1 elliptical dormer, additions extend along all outside walls & are built of frame are 1 story with a shed roof.
Addition 1: stone & stucco, 2.5 story, 3 bay, double pile, 1 brick interior end chimney, gable roof, 9/6 first floor windows, 6/6 second floor windows. **Addition 2:** wood frame, extends from gable of main block, 2.5 story, 2 bay, double pile, single story bay on facade, a porch links this addition to the main block.

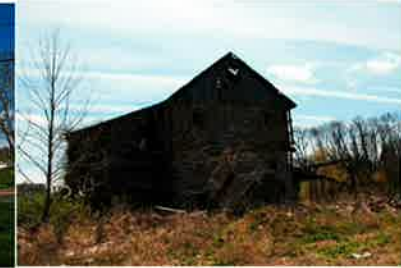
Barn

Bank barn: stone stabling with stone above and frame gables, 2.5 story, 3 bay, forebay wall has been rebuilt, gable roof. **Weigh house:** wood frame with vertical siding, 1.5 story, gable roof, scale is intact. **Root cellar:** barrel vault

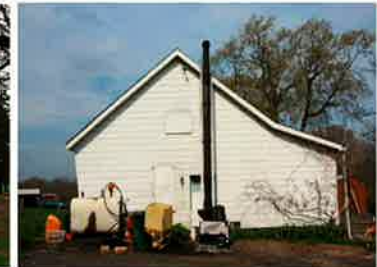
Corn crib

Notes:
Corn crib: wood frame, double drive through with side shed addition & asbestos cladding. Shed: single stry stone structure

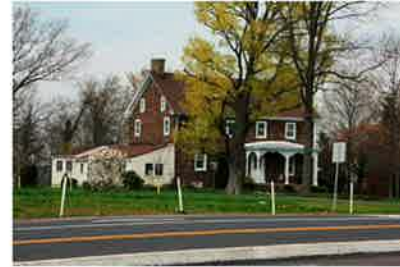
House frontage

Notes:
 Stone, 2.5 story, 4 bay, double pile, 2 brick interior end chimneys, gable roof, altered fenestration, 2 front bays were once arched openings that have been filled in, 2 bay porch with mid 19th century detailing on front, 2/2 windows, shed roof addition to side.

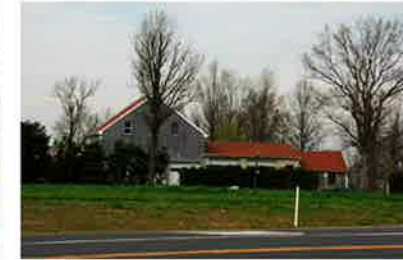
Outbuildings (frontage)

Notes:
Bank barn: stone stabling with frame above, earth ramp, closed forebay, vertical siding, gable roof, hay barn "L" located off both gable ends. Wagonhouse: wood frame with vertical wood siding, 2.5 story, 3 bay, gable roof. Corn crib: double drive through, wood frame, gable roof, clapboard siding. Equipment shed: wood frame with wood siding, open front, raised seam asymmetrical gable roof. Shed: wood frame with vertical siding, 1.5 story, 2 bay, gable roof.

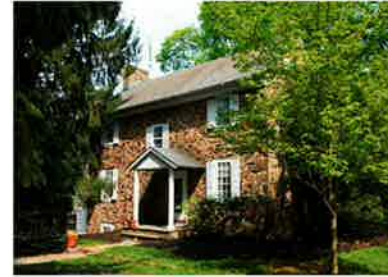
Front elevation (main block)

Notes:
 3 part: stone main block and 2 frame additions; **Part 1:** Stone main block; 4 bay; 2 internal, end, stone chimneys; gable roof; 2.5 story; 9/6 first floor, 6/6 second floor; pedimented entry. **Part 2:** Frame addition; 2 bay; 6/6; central shed roof over first floor wiindows; one external, stone end chimney. **Part 3:** Frame addition; 1.5 story; 6.6; gable roof with shed roof on front first story; central door.

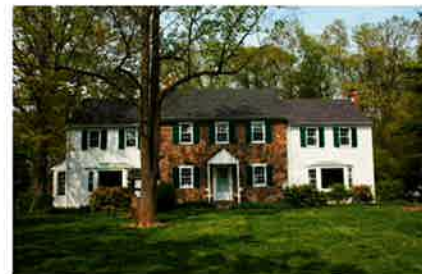
Street elevation

Notes:
 (r to l) Part 1: Frame; 2 bay; large projecting bow window with copper roof on first floor; 6/6 on upper floor; one external, brick chimney; small shed addition to left (exterior) wall. Part 2: Central stone 2.5 story main block; 3 bay; brick, internal, end chimney on the left side; gable roof; pediment over central entry; large dormer on rear roof; 6/6. Part 3: Mirror of Part 1, with shed addition to rear rather than to side.

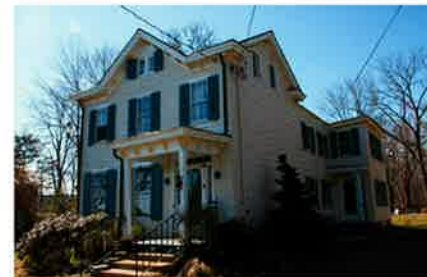
Notes:
 Cross gable roof; 3 bay; bracketed returning cornice; flat-roofed entry porch on right side of elevation; 6/6 sash windows & diamond pane casements in attic story; 2.5 story; stone foundation; 2 additions to rear, both 2 bay, 2 story, flat roof, frame construction; one small "connector" addition to left rear of main block, also frame but likely mid-late 20th century.

Front & side (r) elevations

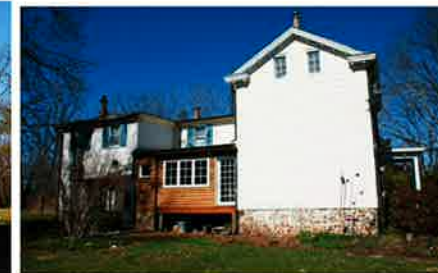
Side (l) elevation

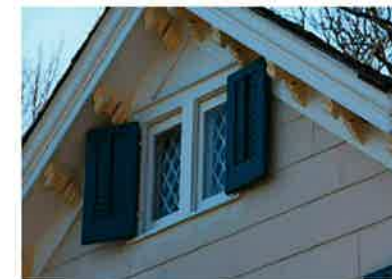
Detail of attic window & cornice

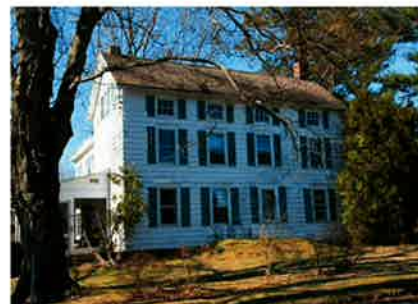
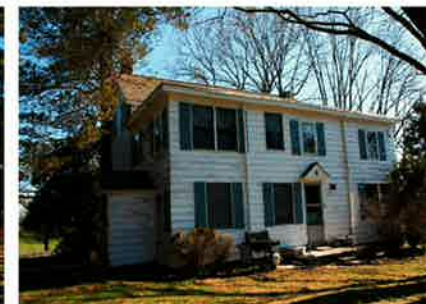
Notes:
 Frame main block with frame addition to rear and a small shed addition to left side; intact wood clapboards; batten wood shutters on front, first story, louvered on front second and attic stories; main block: 6/6 & 3/3 in attic story, 1/1 replacements in first 2 stories; addition: 2/2 (largely replaced); gable roof; 2 interior, brick end chimney (r), concrete internal end chimney (l) on main block; 4 bay (appears to possibly have intially been 3 bay with later 4th (r) bay), 2.5 story main block.

Front elevation with small porch addition (l) Rear elevations

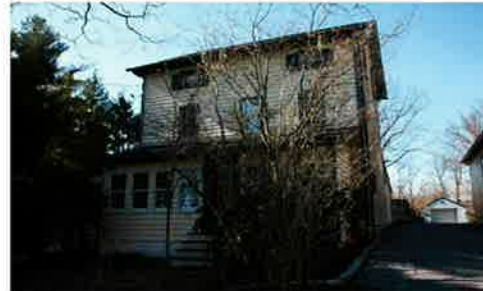
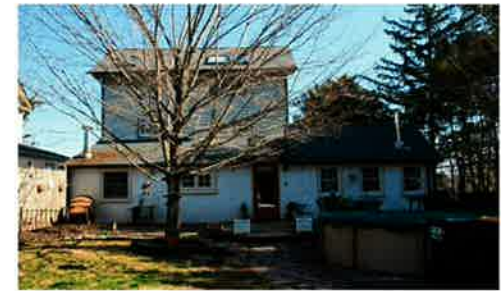
Notes:
 Main block: 3 bay, 1.5 pile, 2.75 story, 6/6; front, shed roof, enclosed porch addition to front; single story frame additions to rear & side. *Listed as #545 in records but building identifies as #543.*

Front elevation Rear elevation

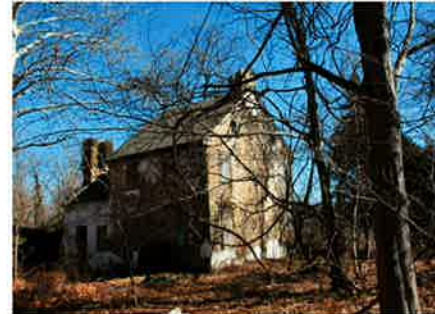
House

Notes:
 Severe demolition by neglect; slate gable roof; 2.5 story; 3 bay; single pile; one stone, interior chimney; one brick, interior end chimney.

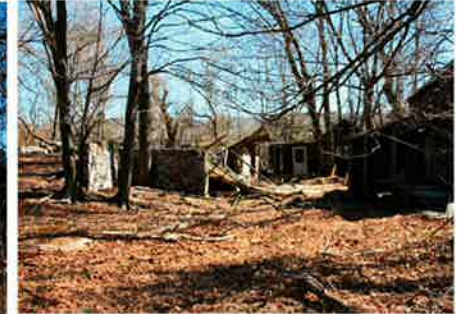
Collection of outbuilding ruins

Notes:
 Condition of all outbuildings is very poor, many are ruins.

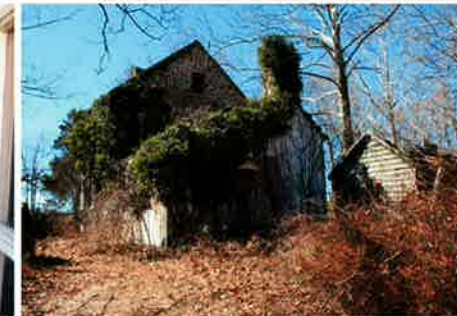
Barn remains

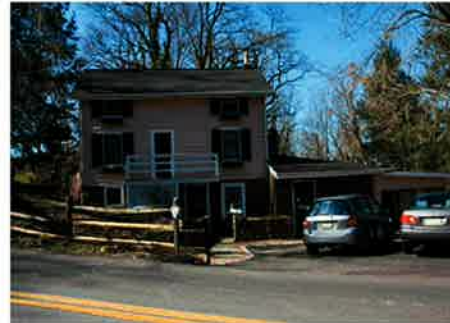
Notes:
 Banked stone foundation / first floor; wood frame above clad in wood clapboards; 1.75 story; 3 bay; single pile; one interior, brick, end chimney with cast chimney pot; low, single story, stone and then frame additions on right side of main block; one small, shed-roofed, frame addition to left-rear.

Street Elevation

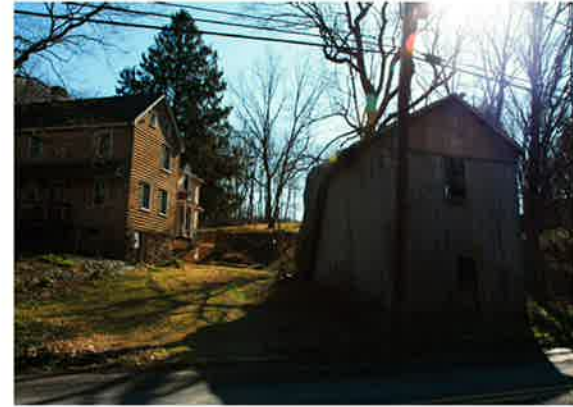
Street elevation (with house in background)

Notes:
 Stone foundation with woodframe above and vertical, "Philadelphia" siding; 2.5 story; single pile; gable roof; split stable doors; 6/6; loft converted to chicken roost. House associated with property is located in Solebury Township. Experiencing some neglect. (House of modern construction visible in site plan).
