**HERITAGE CONSERVANCY
HISTORIC RESOURCE SURVEY FORM**

County Bucks **Municipality** Upper Makefield **Photo #** 4 **Tax Parcel #** 47020128-001

Address / Location 928 Taylorsville Rd. **Resource Name** "Mathias Harvy House" **National Register Status** Significant

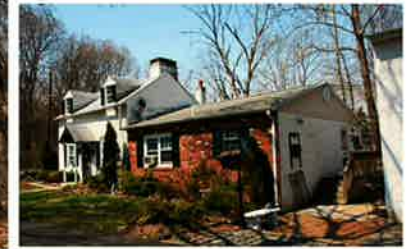
View of addition & main block

Notes:
Stone & stucco construction, 2.5 story, 3 bay, single pile, 1 stone interior end chimney (r), gable roof, 2 gable front dormers, 6/6 windows; brick addition to side, 2.5 bay, single story, gable roof; stucco addition along street facing side, 4 bay, shallow pitched gable roof, oriented perpendicularly to main block, shed roof porch on rear, replacement windows.

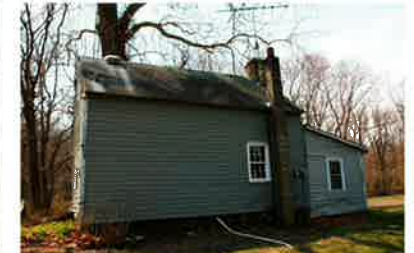
Rear view

Notes:
2 part: **Main block:** wood frame with clapboard siding, 1.5 story, 2 bay, single pile, one stone interior end chimney, one concrete block exterior chimney, gable roof, 6/6 windows, central entry door. **Addition:** 1.5 bay, shed roof, clapboard siding, single story, 6/6 windows, stone foundation.

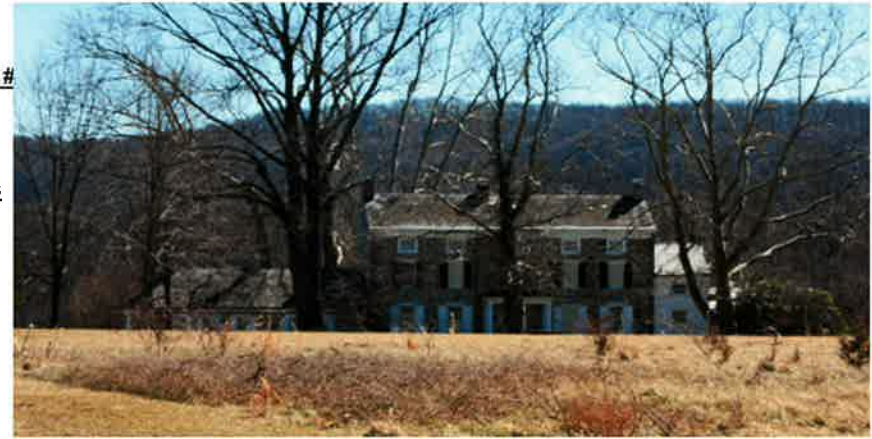
House (street elevation)

Notes:
3 part (4 bay, 4 bay, 1 bay). Gated,
Limited Access.

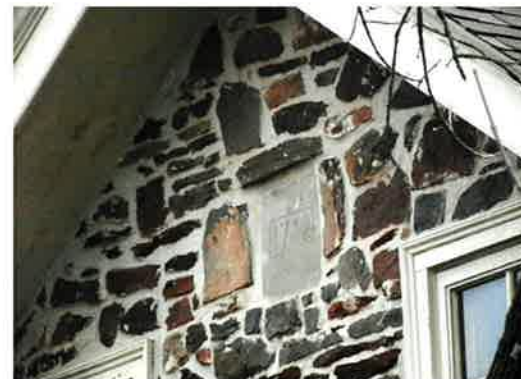
Fieldworker JLJ **Date** March 2011

Past Use Farm **Current Use** Residential

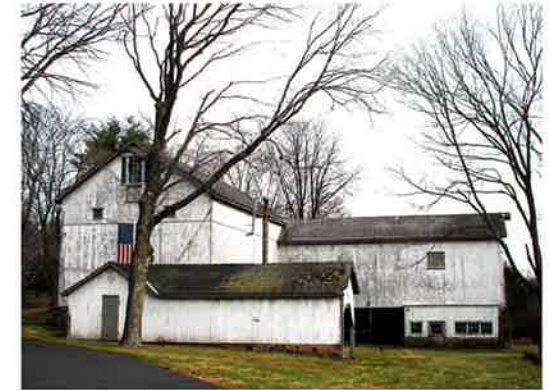
Notes:
 Garage may be an altered carriage house but appears to be modern construction

Past Use Residential **Current Use** Residential
